# Dielectric Spectroscopy of Epoxy/Glass Composite Materials

**Abstract:** *Glass fibre reinforced epoxy (GFRE) material is used in pressboard transformers for optical telecommunication systems, typically at voltages between 1 to 2kV. A programme has been set up to follow the electrical ageing of the GFRE through dielectric and space charge (PEA) measurements. Here we report on the characterisation of the GFRE prior to ageing made by means of linear dielectric spectroscopy. Preliminary results for the aged samples show differences in dielectric response that could be related to de-bonding at the epoxy-fibre interfaces observed in some failed samples.*

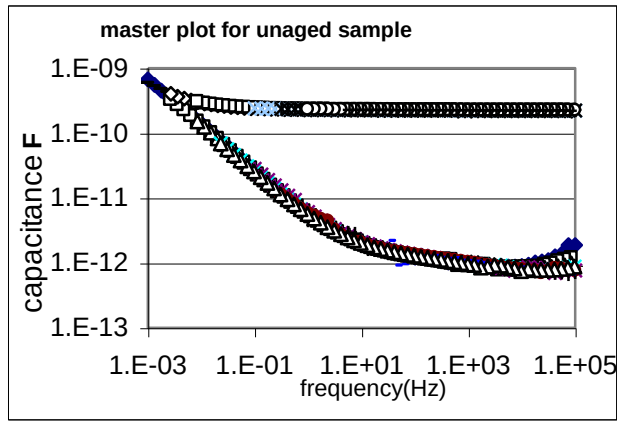
Figure (1). Master plot of the dielectric response of composite, for real (upper) and imaginary (lower) parts of capacitance, for 8 temperatures from 20-90 C

The measurements were performed on disc samples of 54 mm diameter ranging in thickness from 200 to 400  $\mu$ m. The dielectric experiments were carried out using a Solartron FRA system with a custom built temperature control accurate to  $\pm 0.1$ C. Capacitive and loss components were measured over a frequency range from 1 mHz to 100 kHz and from  $T = 20$  C to 100 °C. The results for the composite are shown in Fig 1 in the form of a master plot constructed by translating the data along the  $\log \{\text{frequency}\}$  axis to bring them into coincidence. A broad loss peak was found at high frequencies that were assigned to the  $\beta$ -process of the glassy epoxy. The activation energy of ~0.3 eV found for the characteristic frequency is typical of such processes. A low frequency process was also found that possessed a constant phase angle (CPA) behaviour (i.e.  $C'' \propto C' \propto f^{-p}$  with  $p \approx 0.8$ ). This type of process has been termed a quasi-dc transport [2]. A characteristic activation energy of ~ 1.1 eV was found, but it is not possible to separate this into independent carrier concentration and mobility components. The dielectric response of a glass fibre mat showed a dc conductance at very low frequencies ( $f < 1.3 \times 10^{-2}$ Hz), which transformed into a quasi-dc conductance (CPA) at higher frequencies, Fig 2. Both processes have the same activation energy of 0.46eV implying that the barriers to charge transport are the same in both cases. Measurements were made with two fibre mats as well as one. The results showed that the q-dc process varied with an inverse power of the thickness rather than inversely with the thickness. This result shows that the response observed is truly a bulk response and is what would be expected of a q-dc response originating with a percolation system. [2]. Although the activation energy is much lower than in the q-dc response of the

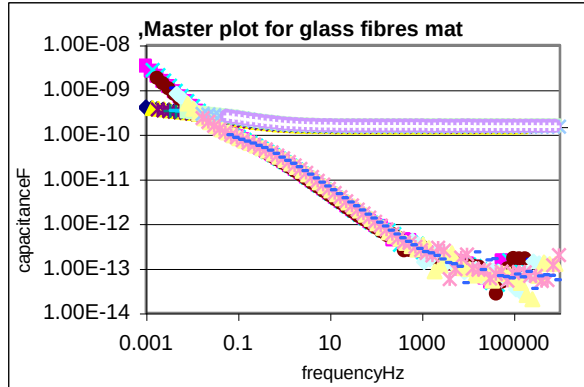
Figure 2. Master plot of the dielectric response of the glass fibre mat, Cr and Cim are real and imaginary parts of the capacitance respectively for the temperatures noted..

composite and the process is moved to higher frequencies it is reasonable to assume that they originate with the same kind of mechanism.

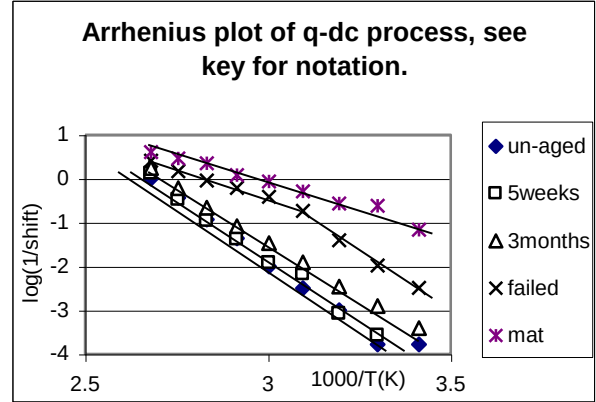
Figure 3. Activation energy of dielectric q-dc response in a range of samples as shown.

Dielectric measurements made on samples removed temporarily from ageing at 5 weeks, and 3months (at  $E=62.5\text{ kV/mm DC}$ ,  $T=15\pm 5^\circ\text{C}$ ) and on the sample that failed show the same form of response as for the unaged composite. However, the q-dc process had moved to higher frequencies. Arrhenius plots for the set of samples measured are shown in Fig 3. It can be seen from this plot that except for the high temperature region of the failed sample, the activation energy has not changed with ageing. There is, however, a displacement towards higher frequencies, i.e. the process moves towards the behaviour observed on the fibre mat alone. This is even more marked in the failed sample where the activation energy changes at high temperatures to a value (0.53eV) close to that of the mat.

The dielectric response of the aged sample showed other features in addition to the q-dc behaviour. In part this may be due to the presence of the bored-out breakdown channel. The activation energy plot shows two regions of behaviour: one at low temperatures that paralleled that of the composite and one at higher temperatures that followed the fibre mat behaviour. A possible explanation is that the response is contributed by two systems in series. In this case the one with largest impedance will dominate. Thus the one with the smallest activation energy will dominate at high temperatures, and vice-versa the one with the largest activation energy will dominate at low temperatures. The values of the activation energies obtained indicate that the two systems correspond to regions where the fibre mat has become substantially de-bonded and regions where the fibre mat is still mainly bonded to the epoxy.

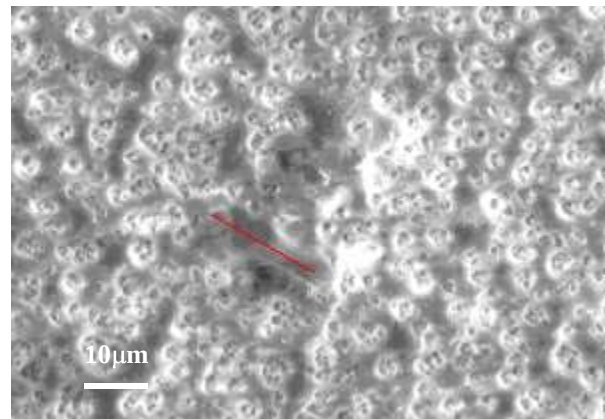
Figure 4. Shows the area near a black line that is indicated by the bar.

The failed sample was noted to have many ‘black lines’ in the plane of the sample (i.e. perpendicular to the field direction) and well away from the breakdown site. It proved impossible to resolve these under the optical microscope, so an SEM analysis was attempted. Figure 4 shows a view of a black line from above and there is little to see. Figure 5 shows the view of such a line in a region where the surface has been removed to expose it to view. The line can be seen to be a  $2.5\mu\text{m}$  void running alongside the glass fibre for millimetres. Figure 6 shows an elemental analysis obtained on a sample prior to ageing using an SEM. The carbon peak is quite strong, as are peaks associated with the elemental content of the glass fibres (e.g Si, Ca, Al). The same analysis taken around the ‘black line’ in the failed sample, Figure (7), showed a strong reduction of the carbon peak with respect to the aluminium peak. This indicates that the black lines are not carbonised tracks such as may be produced by partial discharges.

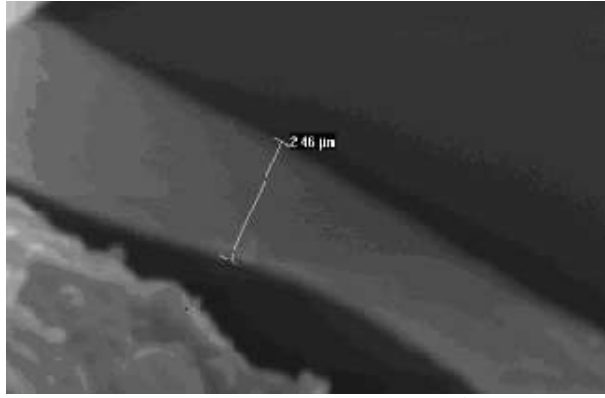
Figure 5 shows the voids (black lines) between the fibres and epoxy. The white line is 2.46  $\mu\text{m}$  long

The above picture allows an interpretation of the dielectric response measurements in terms of the physical changes introduced by thermo-electric ageing. Those samples that have not yet failed show a consistent trend towards a bigger response without any significant change in activation energy, or exponent  $p$ . This implies that the circuit geometry remains the same, but that the resistance and/or the capacitances of the components have reduced. This would be achieved if some portion of the capacitive areas were to become conducting. This is just what would happen if the epoxy became debonded from the fibres in some places. The SEM analysis of the failed sample suggests that this in fact has taken place during ageing.

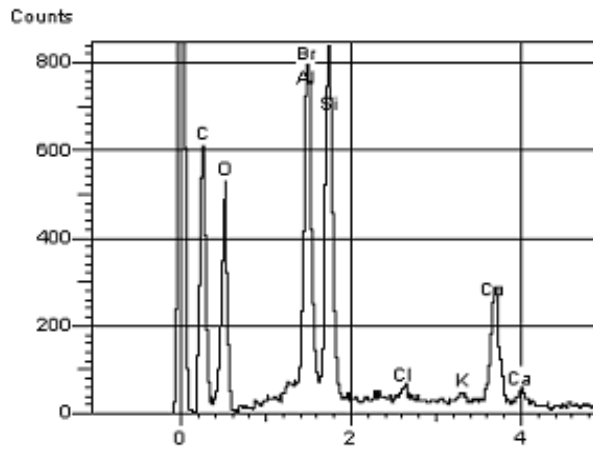
Figure 6 Elemental analysis of un-aged sample (cps vs. keV)
