# The Effect of Continuous Flight Auger Pile Installation on the Soil-Pile Interface in the Mercia Mudstone Group

A dissertation submitted for the  
Degree of Doctor of Philosophy

City University London  
Department of Civil Engineering  
Geotechnical Engineering Research Centre

January 2009

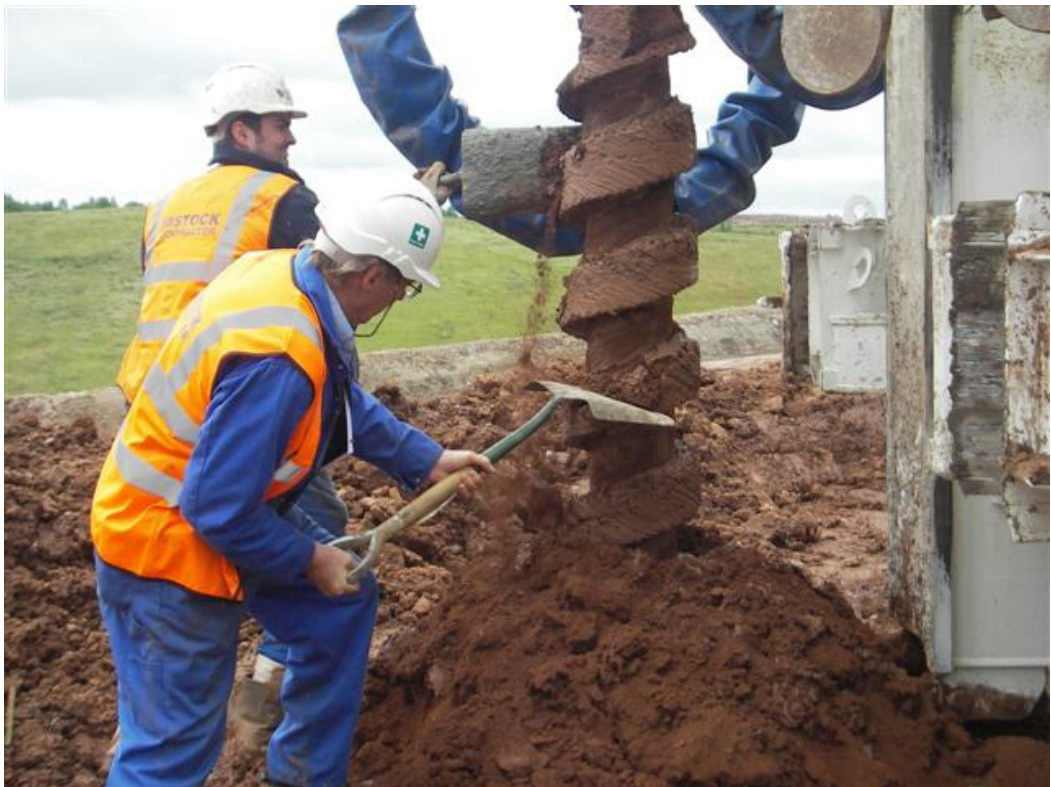
**Figure 4.6 The relationship between the auger and the wet soil around pile MR3. Clear markings can be seen on the inner surface of the shaft, along with the hose used to pour water down the shaft**

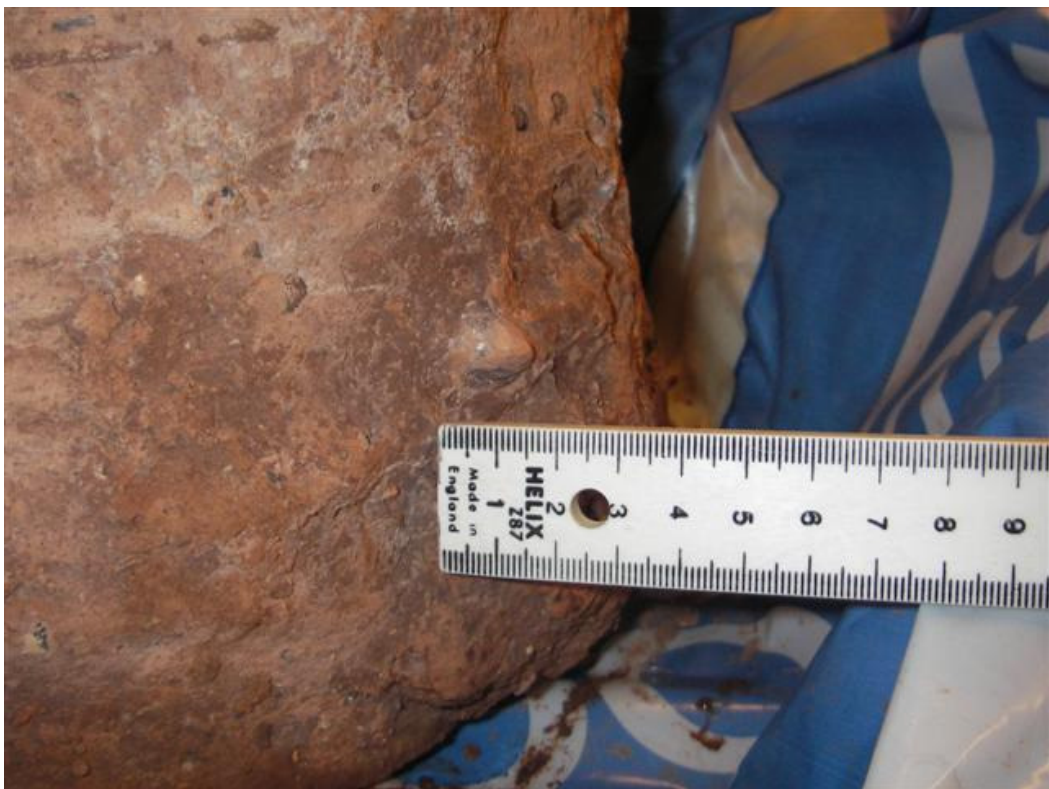
**Figure 4.14** The contact between the remoulded and undisturbed material around pile MR1, 0-495mm below ground level, with remoulded material being of inconsistent width

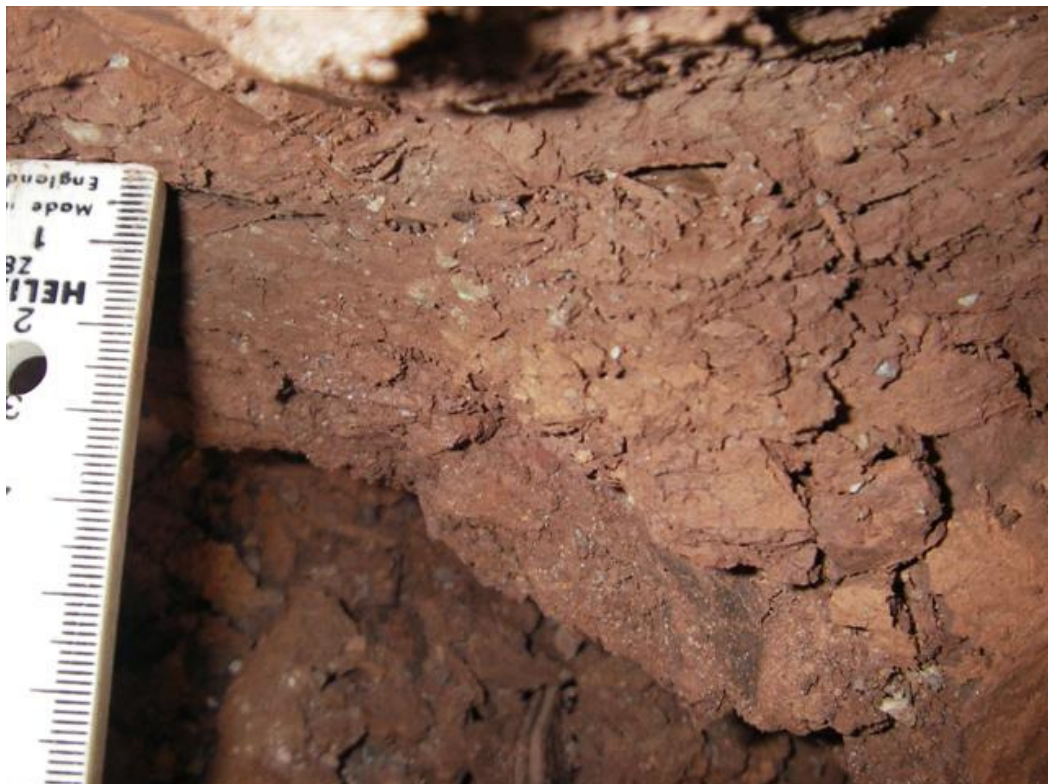
**Figure 4.20** The remoulded zone of pile MR2 at 0-1000mm below ground level. Shows silt aggregations within the remoulded layer. Photo was taken horizontally against the vertical pile shaft

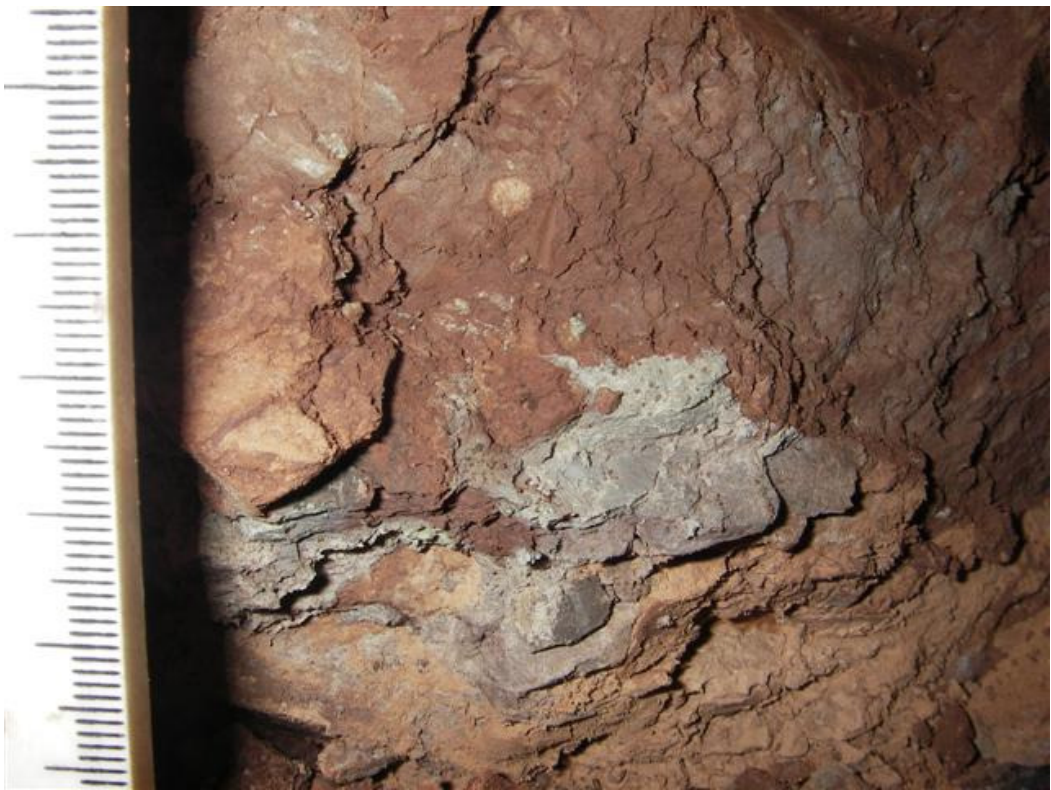
**Figure 4.22 A vertical section through the remoulded zone of pile MR2 1000-1457mm below ground level. Photograph shows remoulded and undisturbed material**

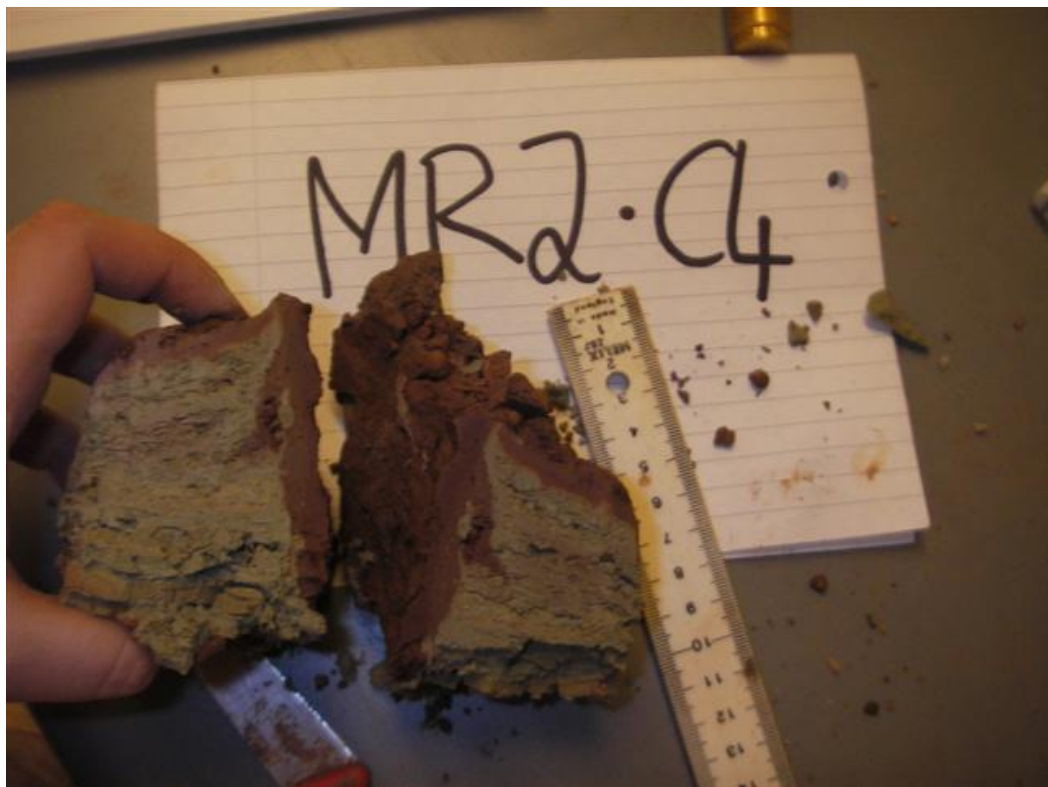
**Figure 4.24** The vertical elevation of the remoulded surface of pile MR2 showing free aggregates within the remoulded layers. 1000-1457mm below ground level

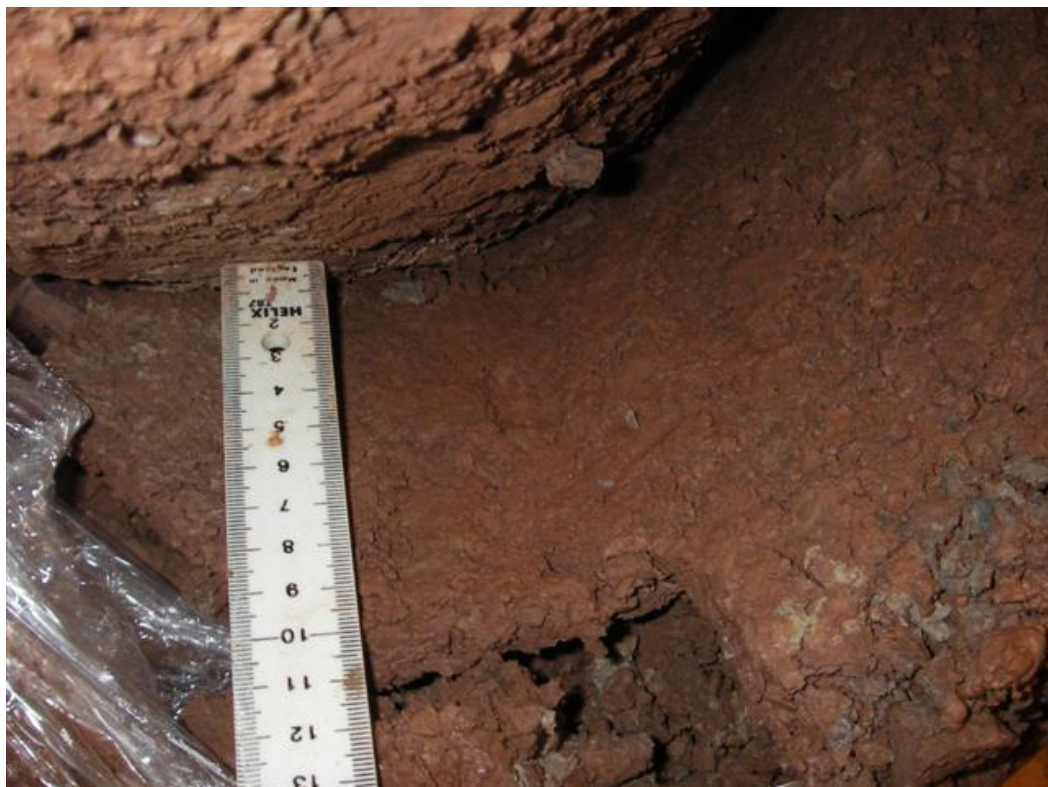
**Figure 4.30 The inner edge of the soil-pile interface in the remoulded soil surrounding pile MR3, base of sample is from 860mm below ground level**

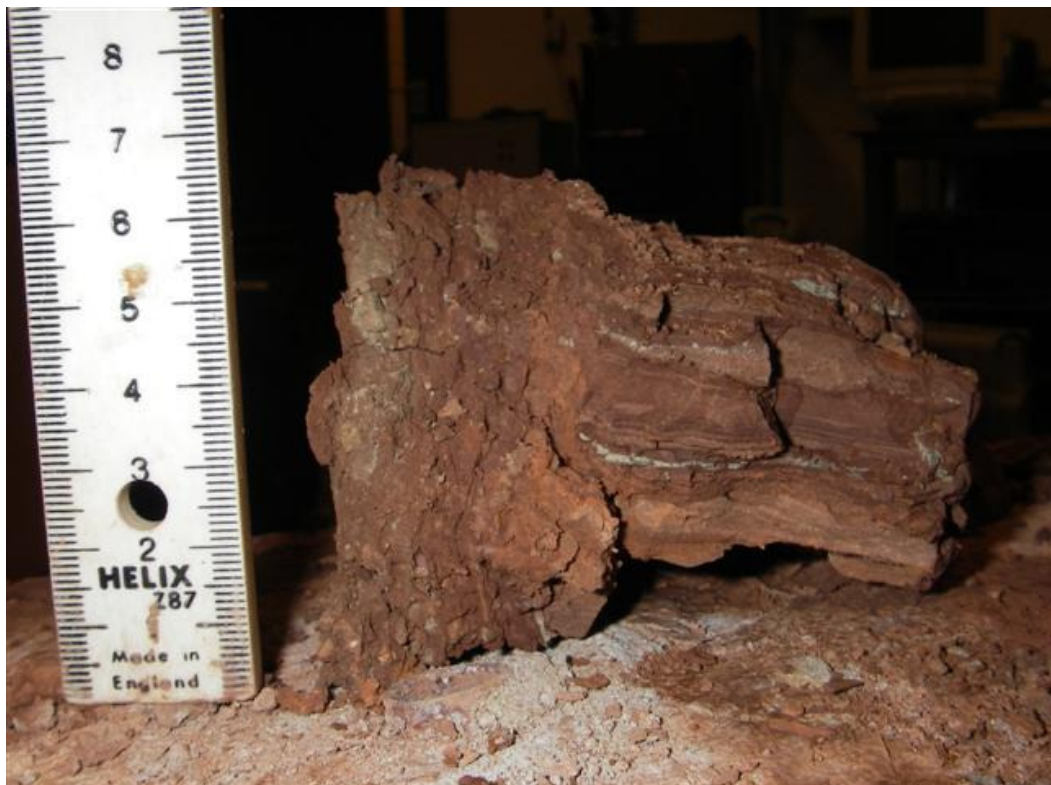
**Figure 4.31 The boundary between remoulded and undisturbed material from the soil surrounding pile MR3 510-860mm below ground level**

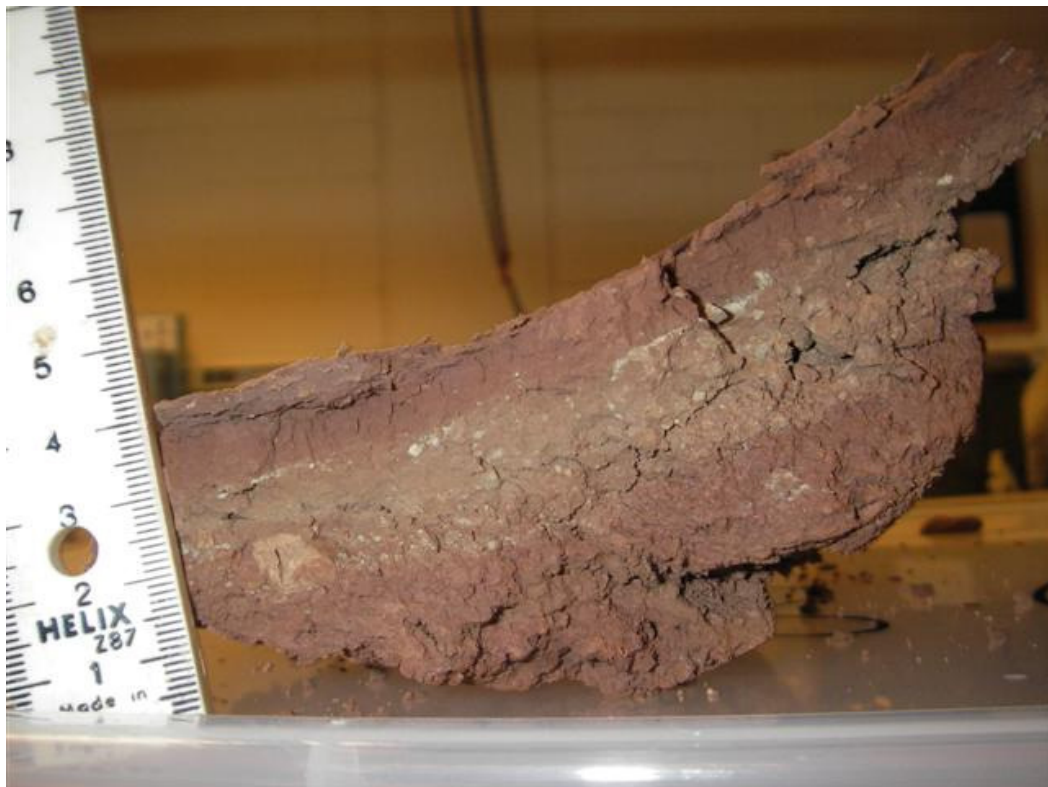
**Figure 4.32 Zoning within the remoulded zone of pile MR3 510-860mm below ground level**

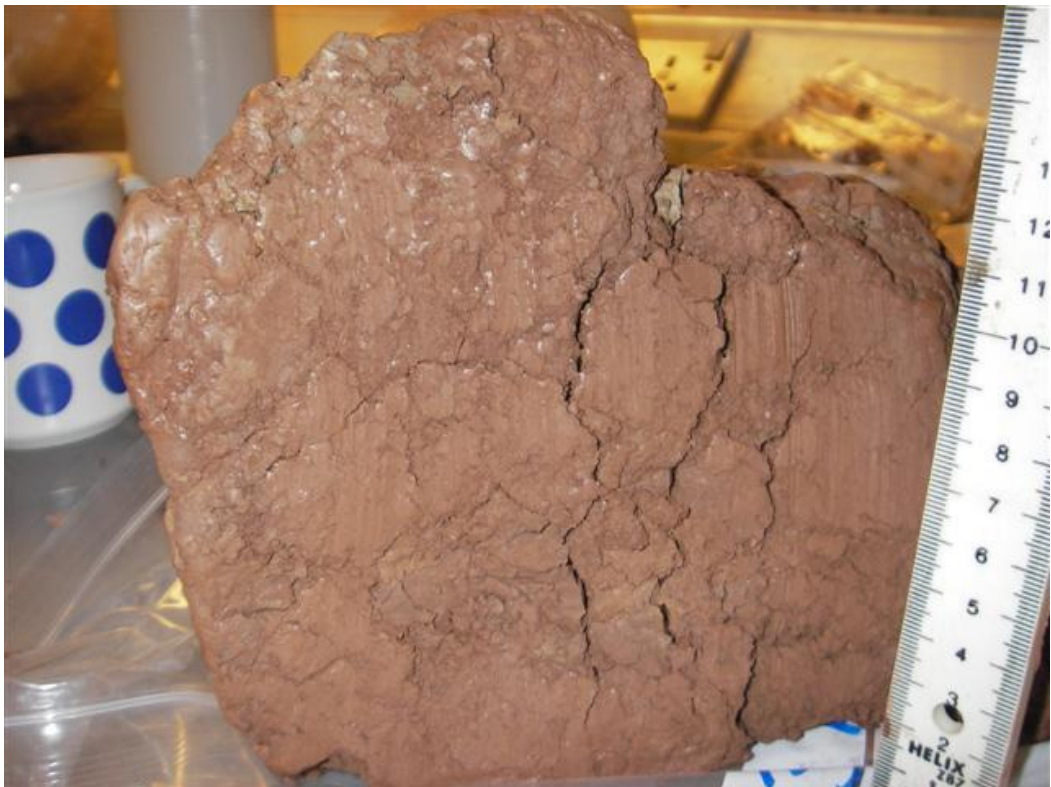
**Figure 4.33 Zoning of remoulding with the soil surrounding pile MR3 860-1210mm below ground level. Then soils is viewed from above, and the pile would have been at the top of this picture**

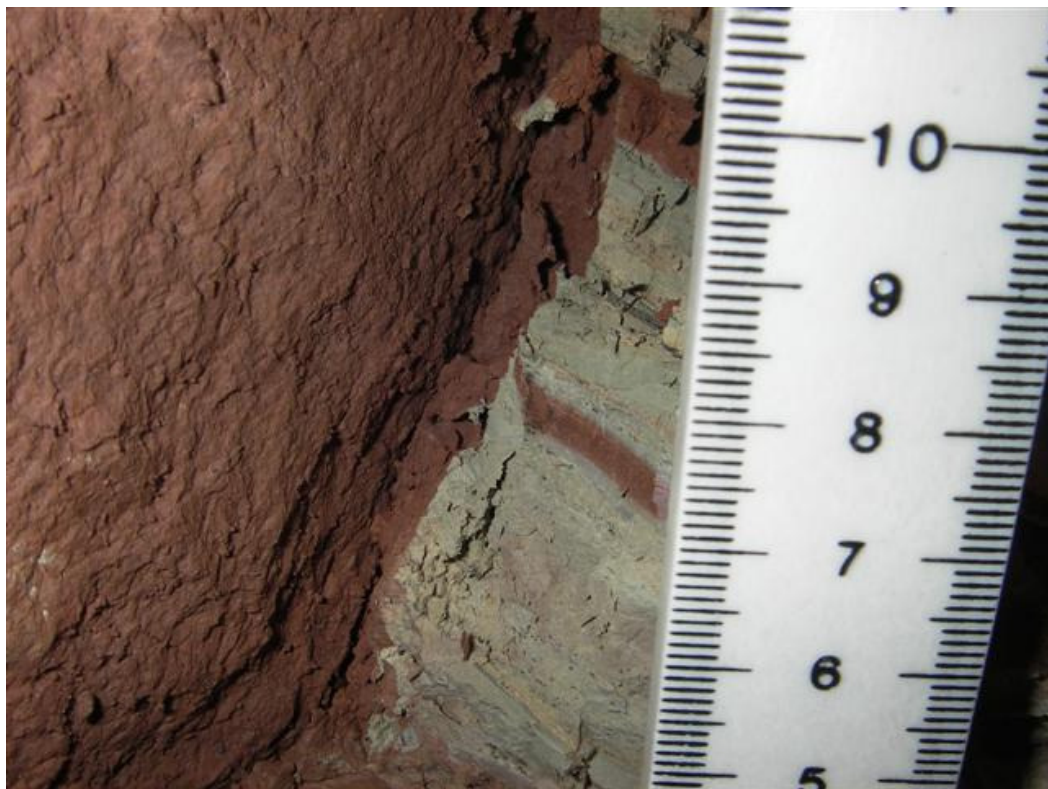
**Figure 4.42 2 layers of remoulded material and their boundary with undisturbed host soil.  
Samples taken from 1342mm below ground level**

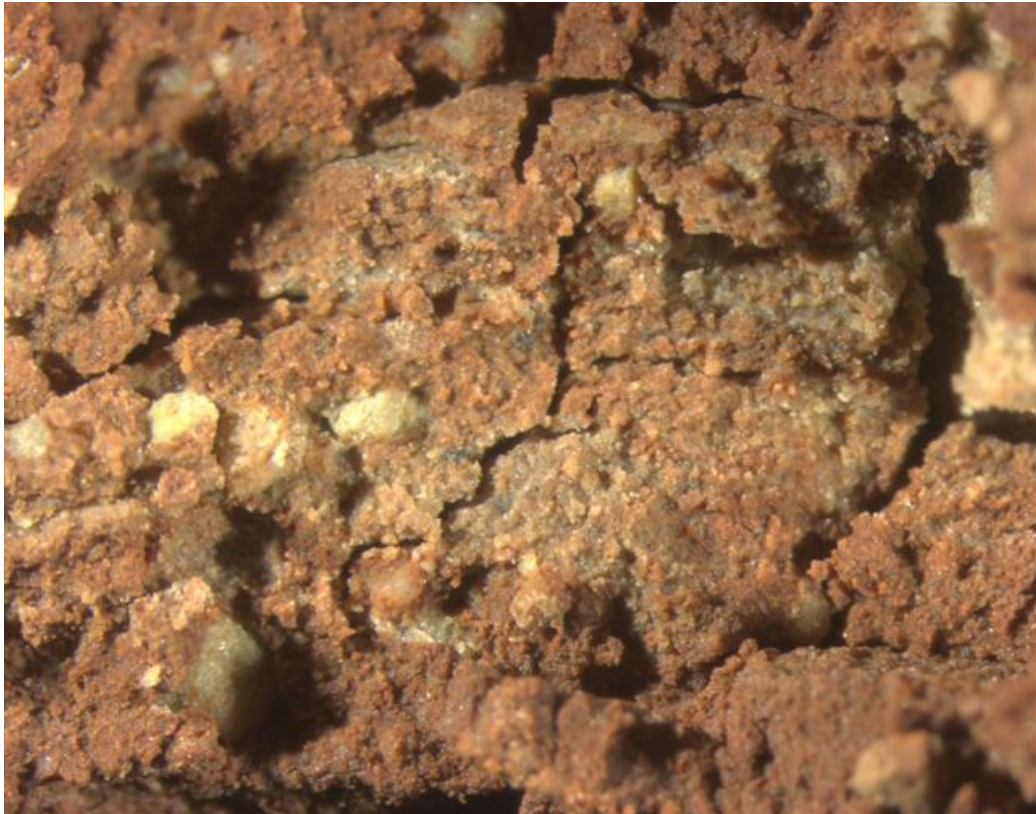
**Figure 4.50 Remoulded zone from around pile MR3 0-510mm below ground level. Photograph is taken from above, with the ruler in the position of the pile. Increments are 1mm in length.**

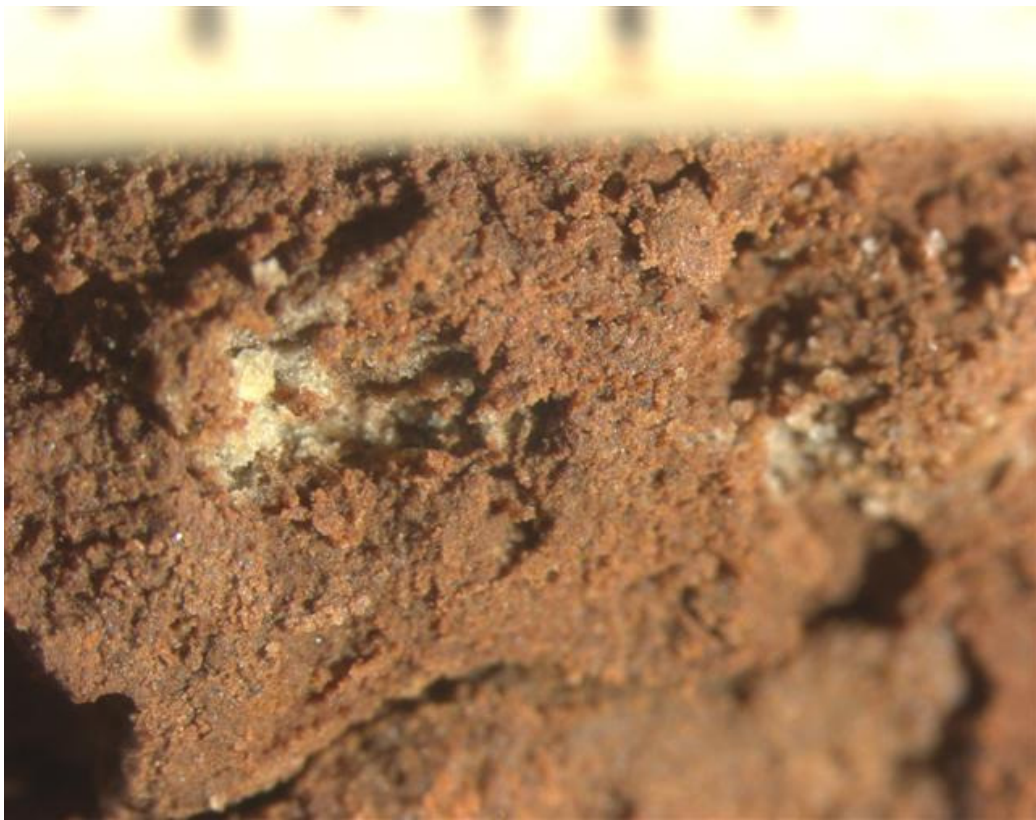
**Figure 4.53** The remoulded zone from around pile MR4, 922mm below ground level. Ruler is in the position of the pile and shows 1mm increments
