**Citation:** Vasilakos, I. (2017). Cavitation in the cylinder-liner and piston-ring interaction in internal combustion engines. (Unpublished Doctoral thesis, City, University of London)

# **Cavitation in the Cylinder-liner and Piston-ring Interaction in Internal Combustion Engines**

Doctor of Philosophy Thesis

**Ioannis Vasilakos**

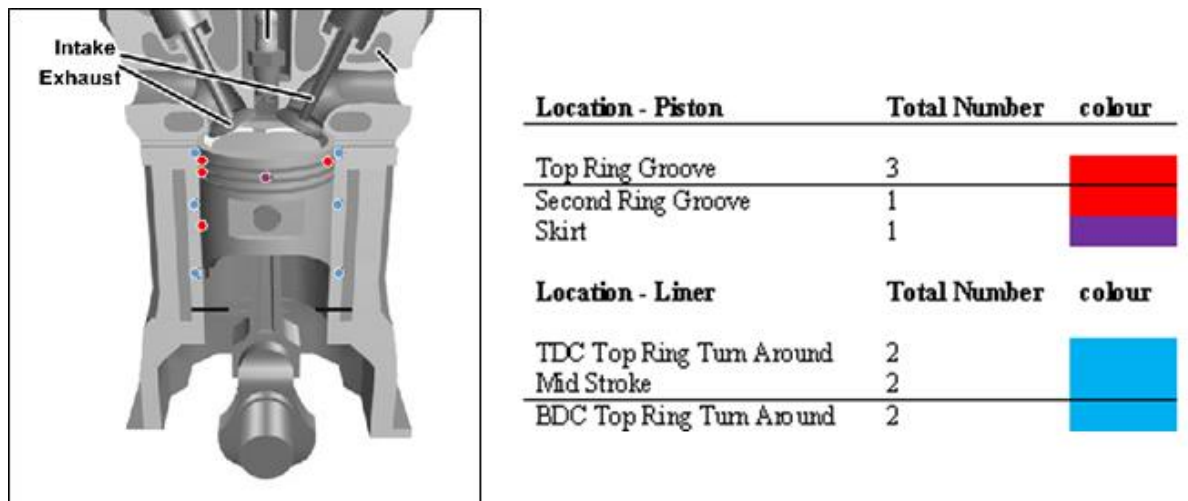
Figure 40 - Model of Thermocouples in Solid Cylinder Block (Ricardo, 2011)

type of engine can operate with gasoline, diesel or even bio-fuels while this particular model can be used as a port-injected or direct-injected engine. The engine used for the tests was a gasoline, spark ignition, port injected engine and the cylinder had a capacity of 450cc. The specific engine comes in two versions out of the factory, the low-pressure version and the high-pressure version. The current model is the high-pressure version that can withstand pressures of up to 160bar. This can be achieved with the use of a forged piston, a forged connection rod, a forged crankshaft and a forged set of inlet and outlet valves. The engine was also equipped with the optional thermocouple modified cylinder block which can perform a full thermal analysis with the use of thermocouples installed on the liner and the piston as shown in figure 40.
