**Citation:** Sun, F-J., Pang, S-H., Zhang, Z-W., Fu, F. & Qian, K. (2020). Retrofitting Seismically Damaged Steel sections encased Concrete Composite Walls using Externally Bonded CFRP Strips. *Composite Structures*, 236, 111927. doi: 10.1016/j.compstruct.2020.111927

# **Retrofitting Seismically Damaged Steel sections encased Concrete Composite Walls using Externally Bonded CFRP Strips**

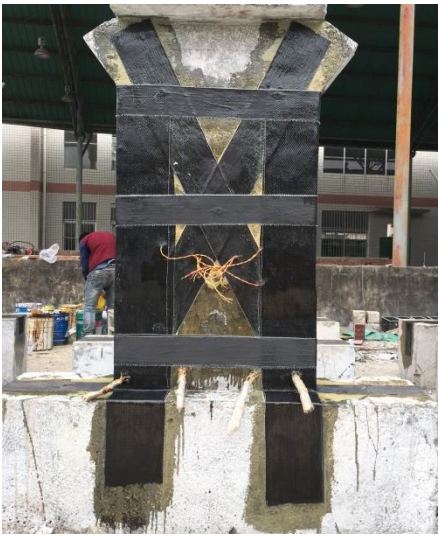
**Fig. 8** Strengthening Scheme 1: (a) drawing, (b) photo

133 The repairing scheme was designed based on the failure mode of the control specimens. As  
134 shown in **Fig. 8a**, for Specimens RW2 and RW3, repairing scheme 1 was adopted. Firstly, two layers  
135 of diagonal strips with width of 150 mm were attached to both face of the wall to restoring the shear  
136 strength (the diagonal cracks were just injected by mortar). Secondly, two layers of C-shaped CFRP  
137 sheet were attached at both flange of the wall as the fracture of channel steel was not repaired. The  
138 layer of C-shaped CFRP sheet was determined using Eq. 1. As shown in the figure, to fully develop  
139 the strength of C-shaped CFRP sheet, the sheets were extended enough length in three directions.

144 Finally, CFRP strips with width of 100 mm was wrapped the wall with spacing of 500 mm to  
145 delay the debonding of the CFRP strips or sheets. Specimen RW4 was repaired by CFRP scheme 2.  
146 Different to RW2 and RW3, the diagonal strips were replaced by vertical strips with width of 100  
147 mm, distributed with spacing of 360 mm. Regarding the C-shaped CFRP sheets and horizontal  
148 wrapped CFRP strips, identical to that of scheme 1.

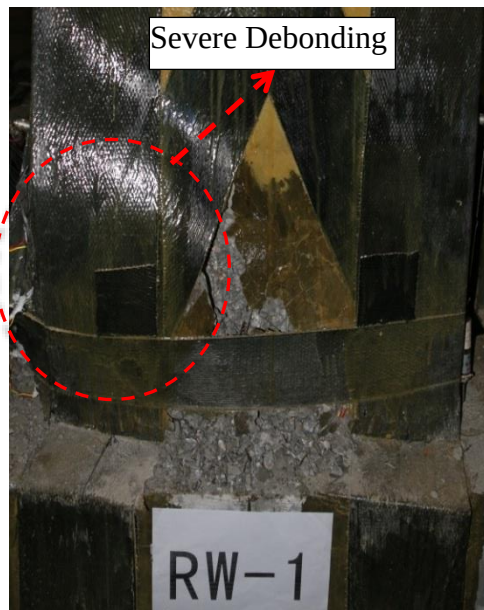
**Fig. 10** Failure mode of repaired specimen RW1: (a) before cutting FRP strips, (b) after removal of partial of CFRP strips

161    bottom foundation with a distance of 280 mm. The failure mode of RW1 was shown in **Fig. 10**. As  
162    shown in the figure, severe CFRP debonding was observed at the lower part of the wall. After cutting  
163    of partial of CFRP laminates, severe concrete spalling was observed. At the corner of the wall, severe  
164    concrete crushing with buckling of replaced rebar was observed.

278 As shown in **Figs. 10** and **11**, replacing the buckled rebar and applied CFRP scheme 1 resulted in  
279 severe concrete crushing at the bottom corner of the walls as well as severe tearing of CFRP sheet at  
280 both sides. However, as shown in **Fig. 12**, if we did not replace the buckled rebar but only applied  
281 CFRP scheme 1, the concrete crushing and tearing of CFRP was less severe which was mainly due  
282 to less compressive stress required. However, comparison of **Figs. 12** and **13**, RW4, which was  
283 retrofitted by CFRP scheme 2 but without replacing buckled rebar, has more severe debonding of  
284 CFRP strips and more severe of concrete crushing and tearing of CFRP sheet at bottom corner of the  
285 wall.

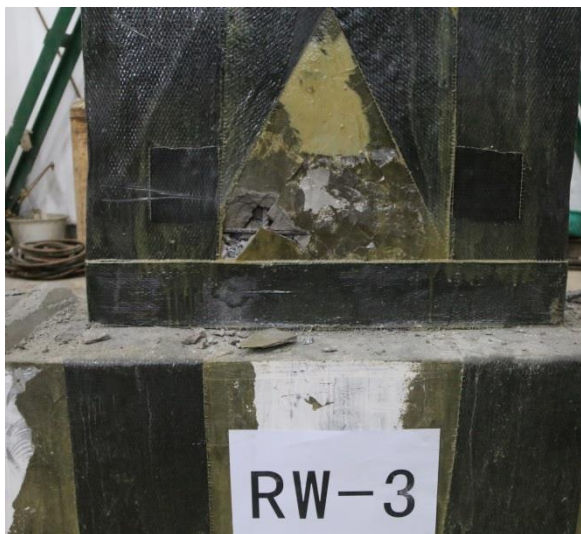
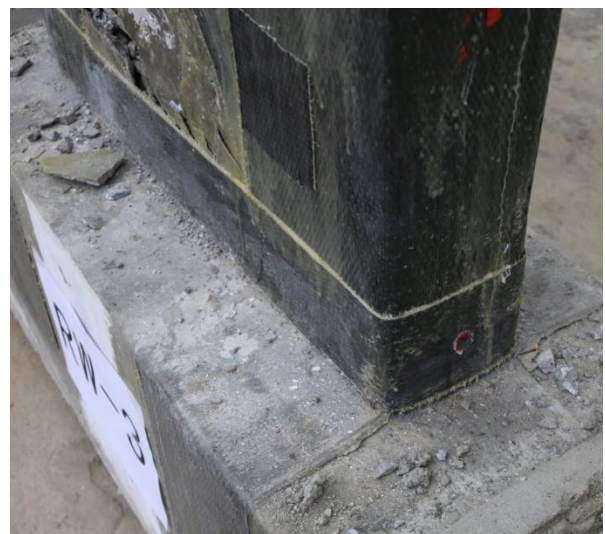
**Fig. 12** Failure mode of repaired specimen RW3: (a) front view, (b) side view

Similar to RW1 and RW2, the debonding was first observed at the diagonal strip at a DR of 0.75 %. At a DR of 1.0 %, debonding was also occurred at the lowest horizontal wrapping. Slight debonding was observed at C-shaped sheet at DR of 1.25 %. Concrete crushing at the corner of the wall was observed at DR of 1.5 %. Further increase of DR, more concrete crushing and debonding was observed. The failure mode of Specimen RW3 is shown in **Fig. 12**. As shown in the figure, the concrete spalling at the front face of the wall was also milder. Moreover, the debonding of C-shaped sheets and concrete crushing at the wall corner was much milder. This could be explained by the fractured or buckling rebar was not replaced. There was the demand of compressive force from concrete was less when flexure strength was considered.

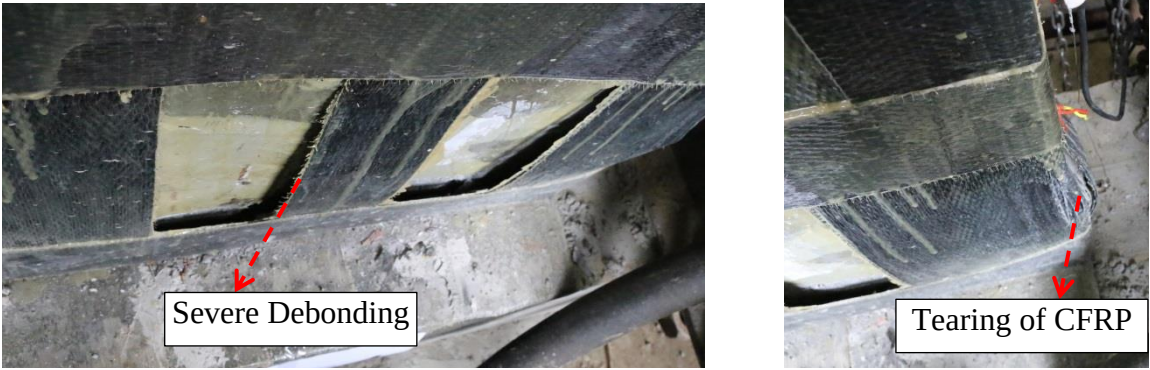
(a) (b)  
**Fig. 13** Failure mode of repaired specimen RW4: (a) front view, (b) side view

Different to above three specimens, RW4 was repaired by CFRP rehabilitation scheme 2. Debonding of CFRP was observed at the right vertical strip at DR of 0.5 %, which was earlier than above three specimens. Tearing was observed at the right vertical strip at DR of 0.75 %. At DR of 1.0 %, debonding was also observed at the lowest horizontal wrapping strips. At DR of 1.25 %, middle vertical strips began to debond and the debonding of the lowest horizontal wrapping strip becomes more severe. Further increase the DR to 1.5 %, CFRP bulk becomes more obvious at the corner of the wall, which means concrete crushing becomes more severe. Further increasing DR to 2.0 %, the debonding zone at the lower part of the wall connected and CFRP strips at the lower part of the wall quit work. **Fig. 13** shows the failure mode of Specimen RW4. As shown in the figure, severe delaminating was observed at the lower part of the wall. Similar to RW3, concrete crushing was much milder than that of RW1 and RW2.
