**Citation:** Cai, B., Wu, A. & Fu, F. (2020). Bond behavior of PP fiber-reinforced cinder concrete after fire exposure. *Computers and Concrete, An International Journal*, 26(2), pp. 115-125. doi: 10.12989/cac.2020.26.2.115

# Bond behavior of PP fiber-reinforced cinder concrete after fire exposure

**Abstract.** To reduce the damage of concrete in fire, a new type of lightweight cinder aggregate concrete was developed due to the excellent fire resistance of cinder. To further enhance its fire resistance, Polypropylene (PP) Fibers which can enhance the fire resistance of concrete were also used in this type of concrete. However, the bond behavior of this new type of concrete after fire exposure is still unknown. To investigate its bond behavior, 185 specimens were heated up to 22, 200, 400, 600 or 800 °C for 2 h duration respectively, which is followed by subsequent compressive and tensile tests at room temperature. The concrete-rebar bond strength of C30 PP fiber-reinforced cinder concrete was subsequently investigated through pull-out tests after fire exposure. The microstructures of the PP fiber-reinforced cinder concrete and the status of the PP fibre at different temperature

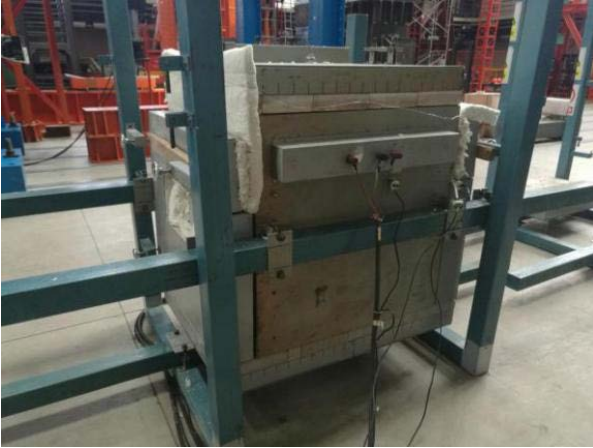
Fig. 3 Electric oven for heating

divided into 5 groups (each 10 specimens) according to heating temperature, including room temperature (RT), 200, 400, 600 and 800 °C. Firstly, the specimens were dried in oven at 100 °C for 24 h, and then heated in a computer-controlled electric oven at the rate of 10 °C/min until reaching the target temperature (Fig. 3).

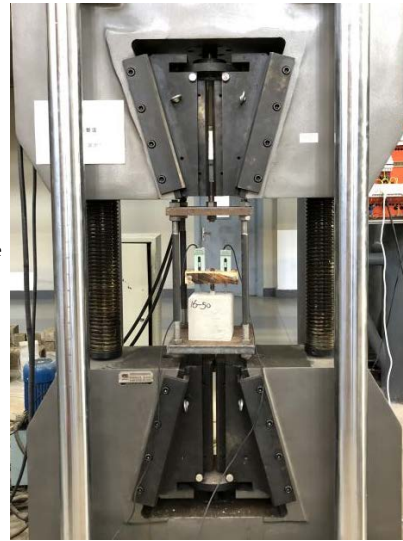
Fig. 7 Pull-out experimental installation

The similar instrumentation of the tests (Fu,2010, Gao,2017, Qian 2020 and Wen 2020,Deng,2020,Guo,2019) was adopted. The pull-out tester was illustrated in Fig. 7. Each specimen was restrained by a steel frame, which consisted of two 30-mm-thick rebar plates and five 25-mm-diameter rebar bars. The frame was clamped by an MTS (Maximum test force: 2000KN, indication accuracy: <1%, motor power: 0.75kW, operating voltage: 380V/220V) loading frame. The rebars of a specimen passed through the reserved hole on the lower plate and was clamped by the lower clamping device. Lubricating oil was

painted in between each specimen and the bottom plate, so as to reduce the specimen-rebar friction during the pull-out tests. Two displacement meters were installed on the top of each specimen to measure the relative slip of the rebar to the specimen, and the pull force was recorded by the force meter of the loading frame. The bond strength of PP fiber-reinforced cinder concrete was calculated as follows:
