**Citation:** Gucunski, N., Slabaugh, G. G., Wang, Z., Fang, T. & Maher, A. (2008). Impact echo data from bridge deck testing: Visualization and interpretation. Transportation Research Record, 2050(1), pp. 111-121. doi: 10.3141/2050-11

## **VISUALIZATION AND INTERPRETATION OF IMPACT ECHO DATA FROM BRIDGE DECK TESTING**

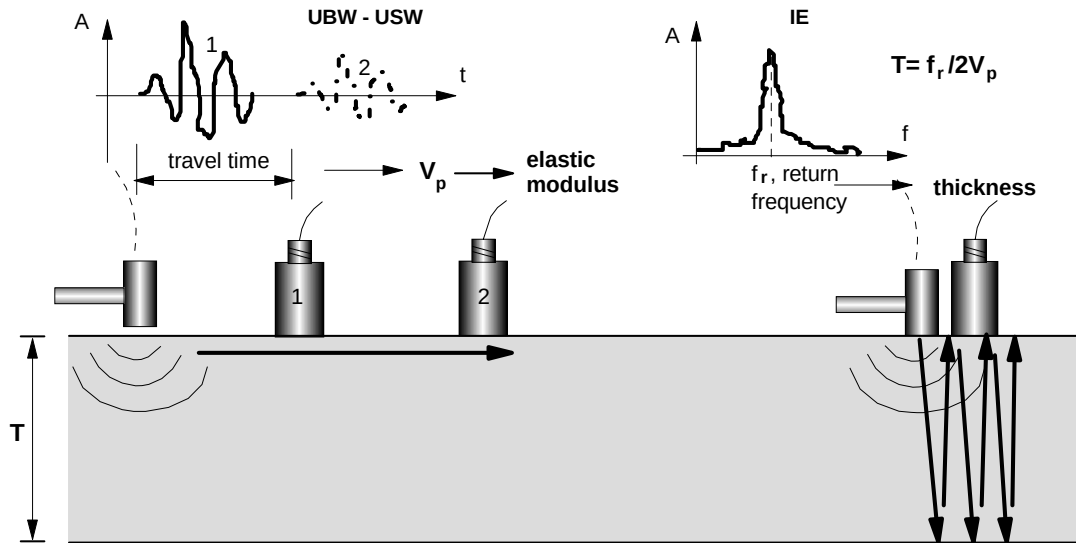
**FIGURE 1** Measurement of bridge deck elastic modulus and thickness by UBW and IE methods.

Application of UBW, USW and IE techniques in the evaluation of a bridge deck is illustrated in Figure 1. In the first part of the evaluation, the UBW and USW tests are conducted using an impact source and two receivers. The UBW technique is used to measure the velocity of propagation of compression (P) waves. By measuring the travel time of the P-wave between two receivers, the P-wave velocity ( $V_p$ ) is calculated. Because it is often difficult to identify P-wave arrivals in an automated way, a more reliable procedure to estimate the P-wave velocity is through a measurement of the surface (Rayleigh or R) wave velocity using the USW test. The USW test is identical to the SASW test (7,8), except that the frequency range of interest is limited to a narrow high frequency range where the velocity of the surface wave (phase velocity) does not vary significantly with frequency (9). Variation in the phase velocity would be an indication of variation of material properties (elastic moduli) with depth. Once the R-wave velocity is determined, it can be well correlated to both compression and shear (S) wave velocities, and thus to the Young's and shear moduli. In the second part of the evaluation, the IE test is conducted using an impact source and a single nearby receiver. Because of a significant contrast in rigidity of concrete and air, the elastic wave is practically entirely reflected off the bottom of the deck back to the deck surface. The frequency of the reflection, called return frequency, can be identified in the response spectrum of the recorded signal. Finally, the depth of the reflector, in this case the deck thickness, can be obtained from the return frequency and the previously determined P-wave velocity, as illustrated in Figure 1.

While the primary objective of IE testing is to determine dominant reflectors, according to the relationship described in Figure 1, a unique thickness or depth of the reflector can be correlated to every component of the frequency spectrum. This is illustrated in Figure 2 by a frequency spectrum, and the corresponding thickness spectrum. The thickness spectrum enables simple data interpretation, because positions of the dominant and secondary peaks describe clearly the pattern of energy partitioning, and thus the degree of delamination. Spectra for a set of points along a single test line can be combined to form spectral surfaces. As shown in the same figure, frequency spectra for one test line on a bridge deck are combined to form a frequency spectral surface and are converted into a corresponding thickness spectral surface. The following observations, regarding the advantages of the two surface types, can be made when linear scales are used for both frequencies and depths. The frequency spectral surface

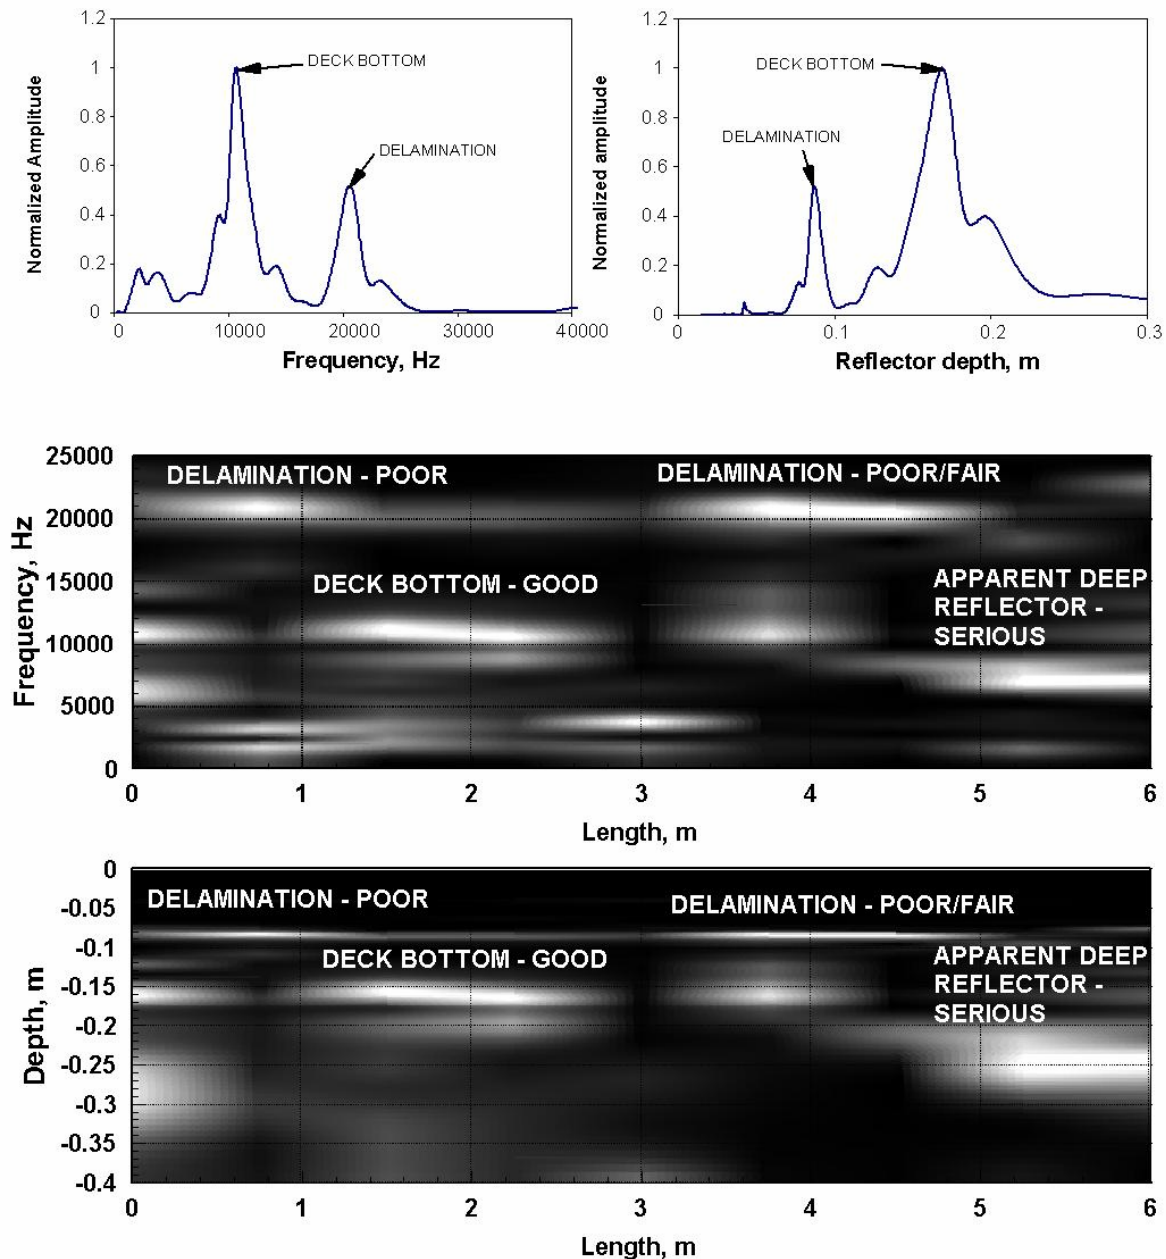
FIGURE 2 Frequency and thickness spectra and spectral surfaces.

emphasizes presence of shallow delaminations, while the thickness spectrum emphasizes presence of apparent deep reflectors, deck zones in a serious condition that will be discussed in the following section (10). Because the thickness spectral surface represents a more natural choice for data viewing, a properly selected nonlinear depth scale can provide a well-balanced image for identification of all detected reflectors.

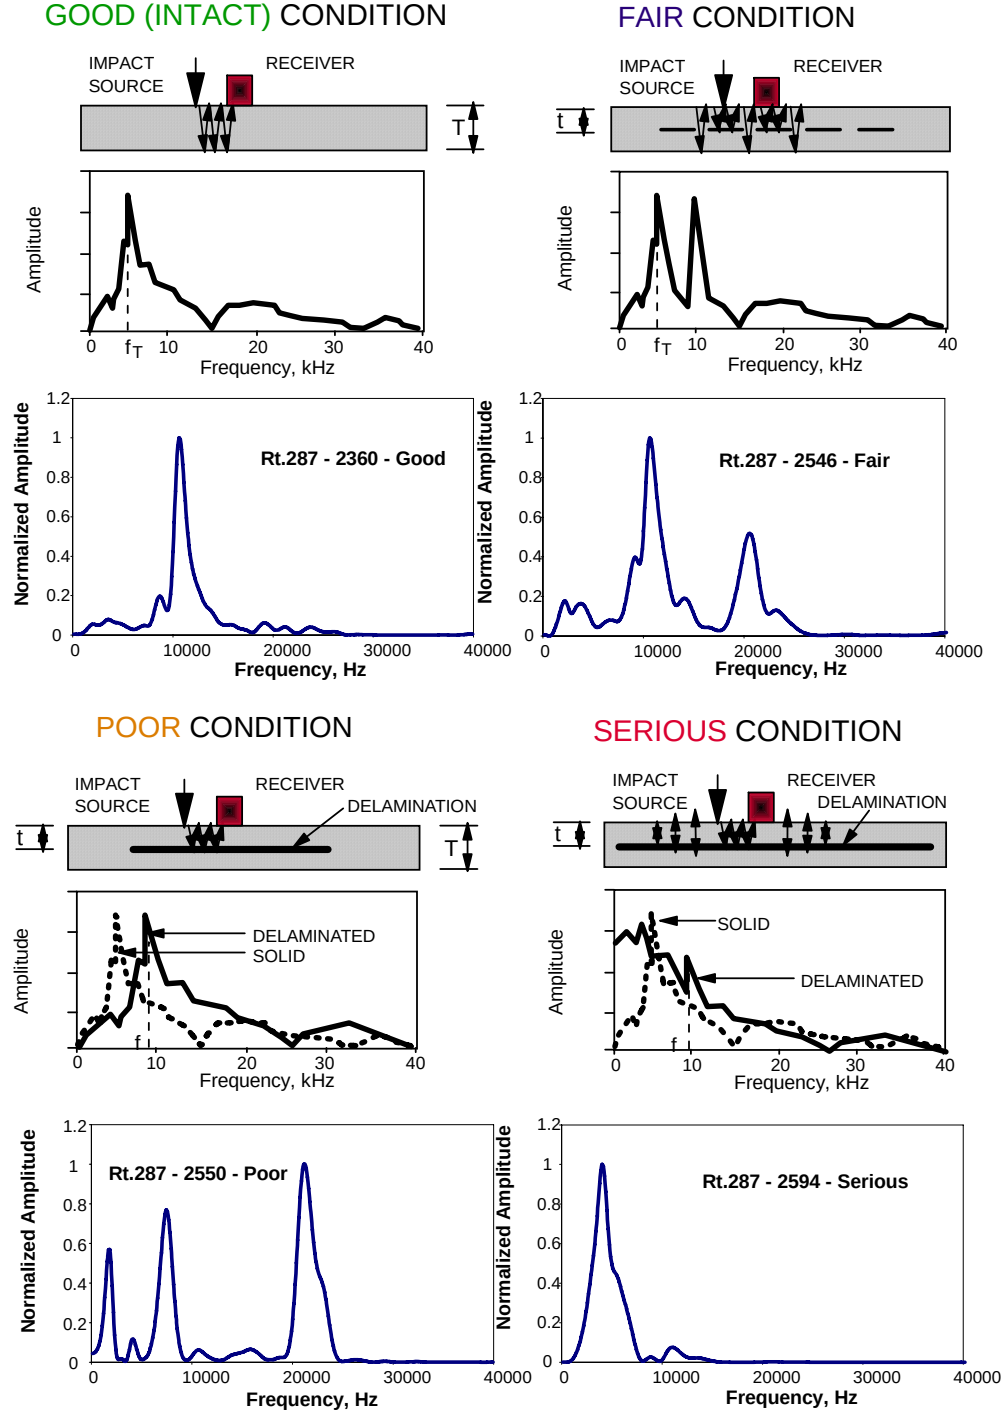
**FIGURE 3** Grades for various degrees of deck delamination.

that particular section of a deck as a part of the condition assessment process. This is illustrated in Figure 3. In the case of a sound deck (good condition), a distinctive peak in the response spectrum corresponding

to the full depth of the deck, can be observed. This is illustrated by two spectra under the schematic of the bridge deck. The upper spectrum in the figure represents a schematic of the expected spectrum, while the lower spectrum is taken from actual field testing. Initial delamination (fair condition) is described as occasional separations between the two deck zones. It can be identified through the presence of two

distinct peaks, indicating energy partitioning from two dominant wave propagation patterns. The first peak corresponds to reflections from the bottom of the deck, while the second corresponds to reflections from the delamination. Progressed delamination (poor condition) is characterized by a single peak at a frequency corresponding to a reflector depth that is shallower than the deck thickness, indicating that little or no energy is being propagated towards the bottom of the deck. Finally, in a very severe case of a wide delamination (serious condition), the dominant response of the deck to an impact is characterized by a low frequency response of flexural mode oscillations of the upper delaminated portion of the deck. This response is almost always in the audible frequency range, unlike response of the deck in the fair and poor condition that may be in the ultrasonic range. Because it is significantly lower than the return frequency for the deck bottom, it produces an apparent reflector depth that is larger than the deck thickness.

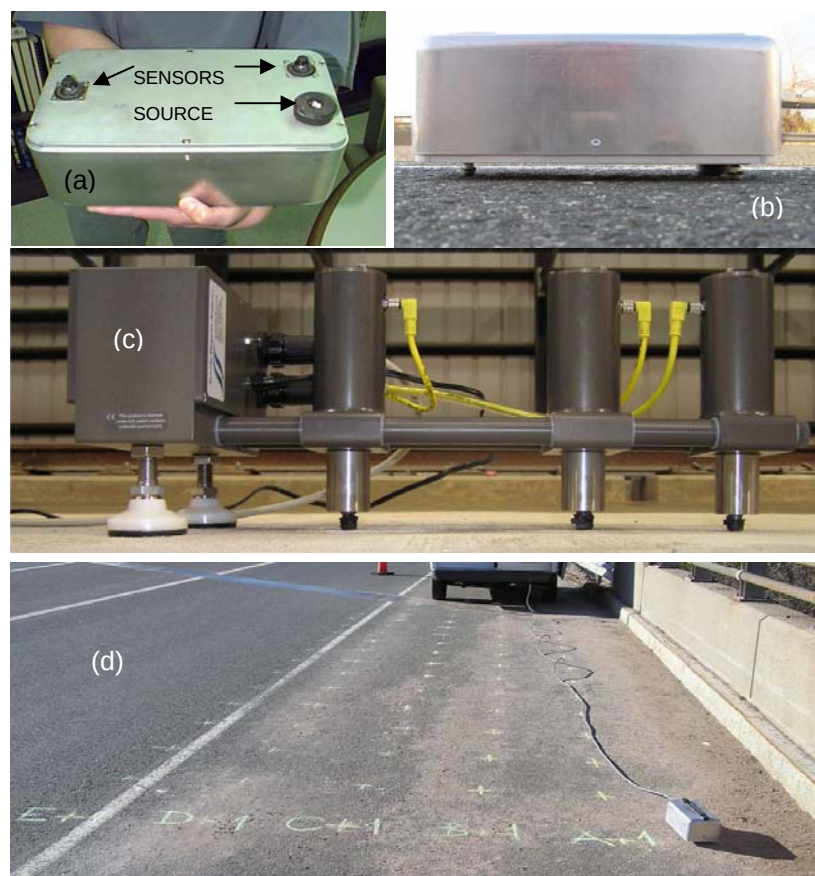
**FIGURE 4** Older and newer versions of PSPA sensor box (a and c), and field implementation (b and d).

IE is commonly implemented in deck evaluations by conducting point testing on a grid of selected spacing. The testing is conducted using impact echo devices, which in some case integrate other ultrasonic seismic methods. One of such devices is PSPA with has a sole purpose of evaluation of surface pavement layers and bridge decks. The device integrates all three previously described ultrasonic techniques (UBW, USW, IE). The core of the PSPA system is a sensor box (Figure 4a), a box containing a solenoid type impact hammer and two high frequency accelerometers, 7.5 and 21.5 cm away from the hammer. All controls and data acquisition are in a computer that is connected by a serial cable to the sensor box. A new design of the PSPA (Figure 4c) has all data acquisition and control elements are a part of the unit. Field evaluation of bridge decks is typically done on grids of 0.6x0.6 m to 0.9x0.9 m (Figure

4d). Testing using the PSPA is simple and for a single point takes less than 30 seconds. The sensor box is placed at the test point (Figure 4c), a series of impacts (6-10) of 50  $\mu$ s duration are applied and acceleration histories are recorded. The testing is fairly insensitive to traffic induced vibrations because of the high frequency range used—typically between 2 and 30 kHz.

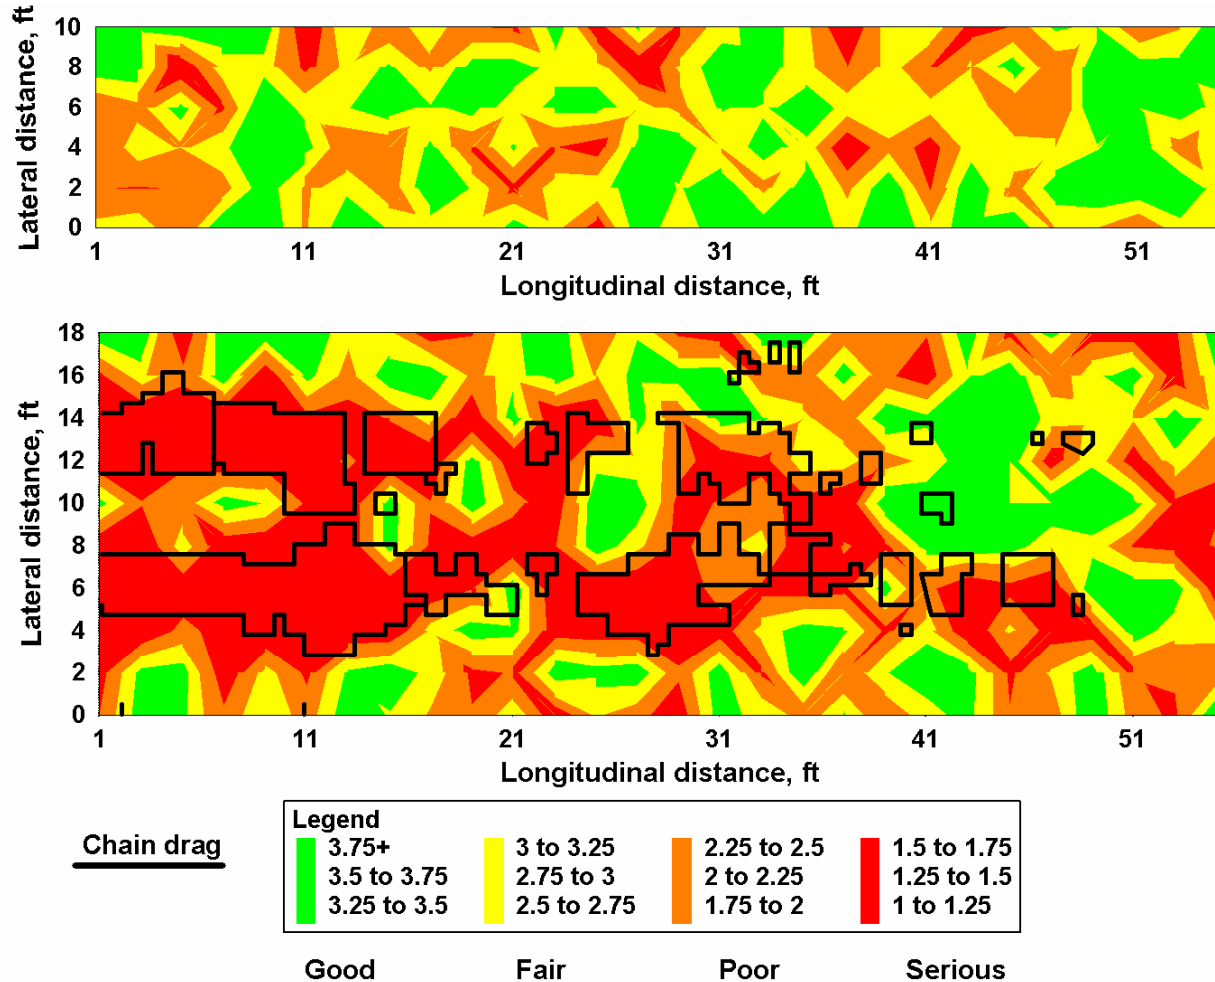
**FIGURE 5** Condition assessment maps for Carter Creek Bridge (top) and Van Buren Bridge (bottom).

PSPA testing results are commonly described in terms of shear and Young's moduli (or P- and S-wave velocity) distributions, and condition assessment distributions (with respect to the degree of delamination). This is illustrated by conditions maps for sections of two bridges in Virginia, Carter Creek and Van Buren bridges (Figure 5). As can be observed in the upper condition assessment plot for the Carter Creek bridge, the deck is in a good condition and only smaller zones of initial and progressed delamination, and minor zones of a deck in a serious condition, can be identified. On the other hand, the bottom condition assessment plot for Van Buren bridge deck illustrates a deck in a significantly deteriorated condition. Zones of all previously described conditions (grades) can be identified in the condition assessment plot. Since the deck was also evaluated by chain dragging, the PSPA results were compared to those of the chain drag. The comparison points to similarity of the two approaches in detection of areas with progressed delamination (poor to serious condition). The ability of the chain drag to identify zones in a serious condition can be explained by the fact that the frequency response in such cases is in the audible range. On the other hand, the most of the zones identified by the PSPA as zones of initial delamination (fair to poor grades) were not detected by the chain drag. This ability to detect signs

of initial delamination represents a significant advantage of the PSPA device (seismic ultrasonic testing) over the chain drag approach. It allows more accurate definition of boundaries of delaminated zones, better prediction of delamination progression, and leads to better assessment and timing for implementation of rehabilitation measures.

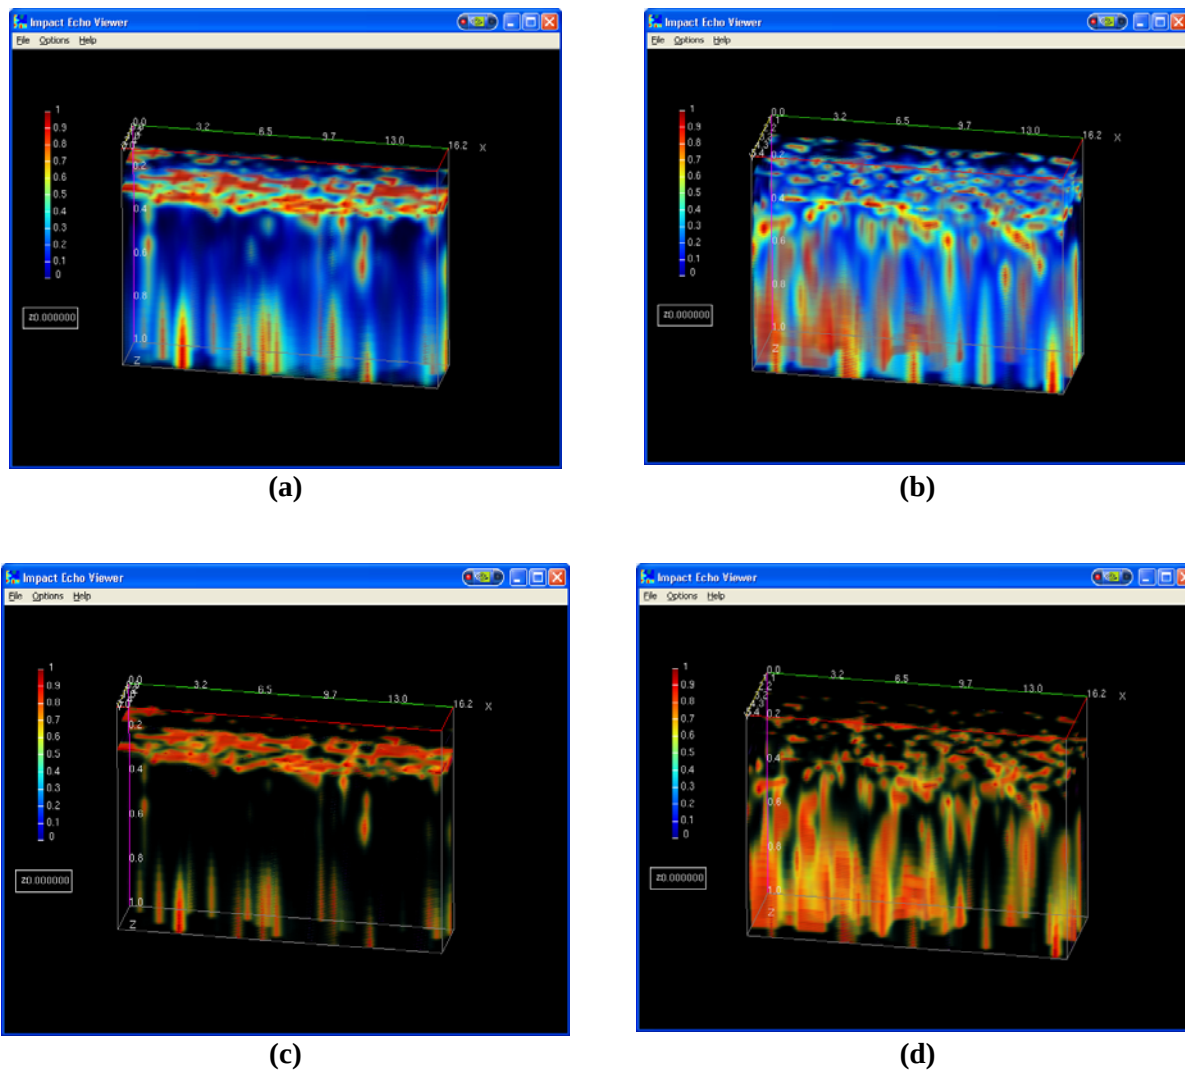
**FIGURE 6** Interactive visualization of IE data. Carter Creek Bridge (a) (c), Van Buren Bridge (b) and (d).

A 3D visualization platform for IE data was developed. The platform is written in C++ for Microsoft Windows, and depicted in Figures 6a and 6b for Carter Creek and Van Buren bridge decks. The IE data consists of a reflection value, normalized in the range [0, 1], and sampled on a discrete 3D grid of voxels. Using OpenGL, the data is rendered as a series of texture-mapped planes that slice through the volume, where the reflection strength is used as an index into a colormap look-up table that consists of red, green, blue, and alpha (transparency) values. The user can rotate and shift the camera position, enlarge or shrink the volume and observe the data from different viewing positions and angles. Additionally, as shown in Figures 6c and 6d, the user can interactively adjust the transparency so that weaker reflectors become more transparent, allowing better visualization of the strong reflectors. Similar to the observations in the previous section, in the visualizations provided in Figure 6 it can be noticed that the Carter Creek Bridge, visualized in 6a and 6c is in reasonably good condition. The primary reflections are coming from the bottom of the deck. In contrast, the Van Buren Bridge, visualized in Figures 6b and 6d, has a large number of reflections throughout the volume, indicating a highly deteriorated condition. Data presented in 3D viewer can be inspected as vertical and horizontal cross sections or slices, as illustrated in Figure 7.

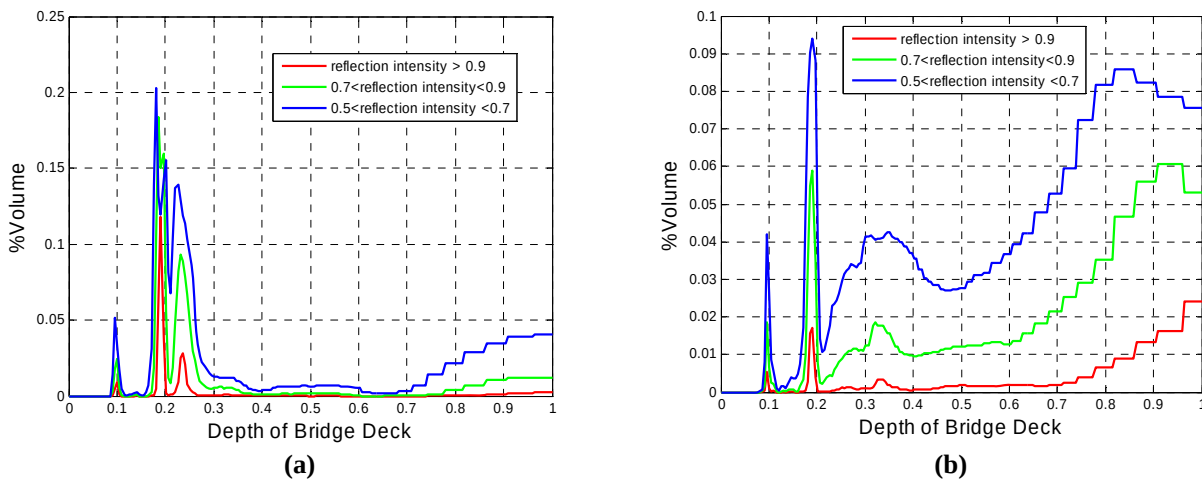
**FIGURE 8** Percent Volume for Various Reflection Intensities vs. Depth. Carter Creek (a), Van Buren (b).

To locate the depth of the strongest reflectors, which could be indicators of defects in a bridge deck, it is very useful to study the relationship between the reflection intensity and depth of the bridge deck. In Figure 8a, strongest reflections appear around a depth equal to about 0.2 m, which corresponds to the bottom of the deck. This phenomenon indicates that the deck is in good condition, consistent with the previous observation and analysis. However, in Figure 8b, strong reflections appear throughout the deck, particularly in the lower regions (close to a 1 m depth) of the deck, indicating presence of flexural oscillations of the upper portion of the deck and thus serious condition.

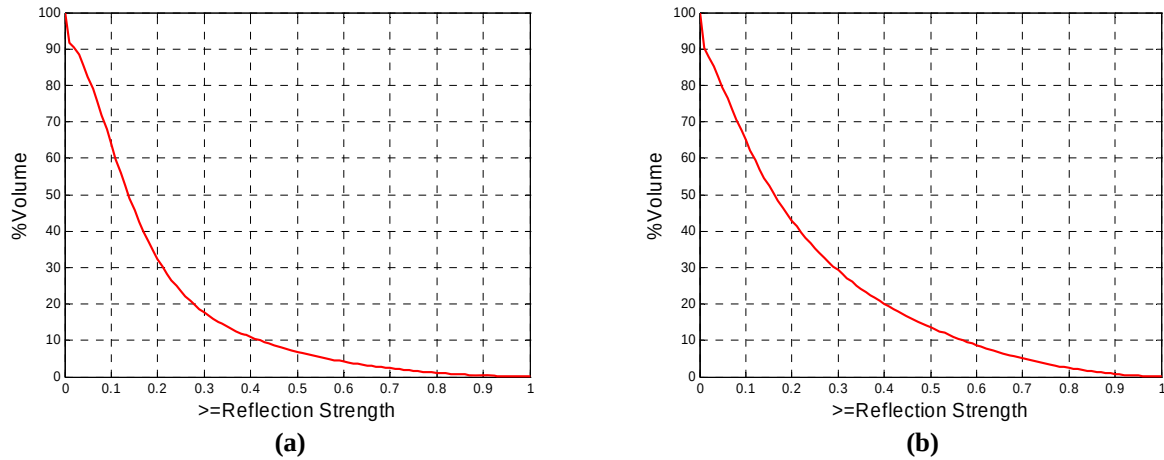
**FIGURE 9** Cumulative Distribution of Reflection Intensity. Carter Creek Bridge (a) and Van Buren Bridge (b).

We also examined the cumulative distribution of reflection intensities, shown as Fig. 9. Specifically, these graphs plot the percentage of the IE reflectivity that is greater than or equal to a specific reflection strength. From this figure, it is obvious that strong reflectors at depths deeper than the bottom of the deck are existing in the Van Buren (b) are more than those in the Carter Creek Bridge (a). This is considered to be a sign that the former bridge deck is in a worse condition. Quantitatively, this can be presented in terms of the areas under the curve, which for Carter Creek is 1909.8 and Van Buren Bridge 2376.6.

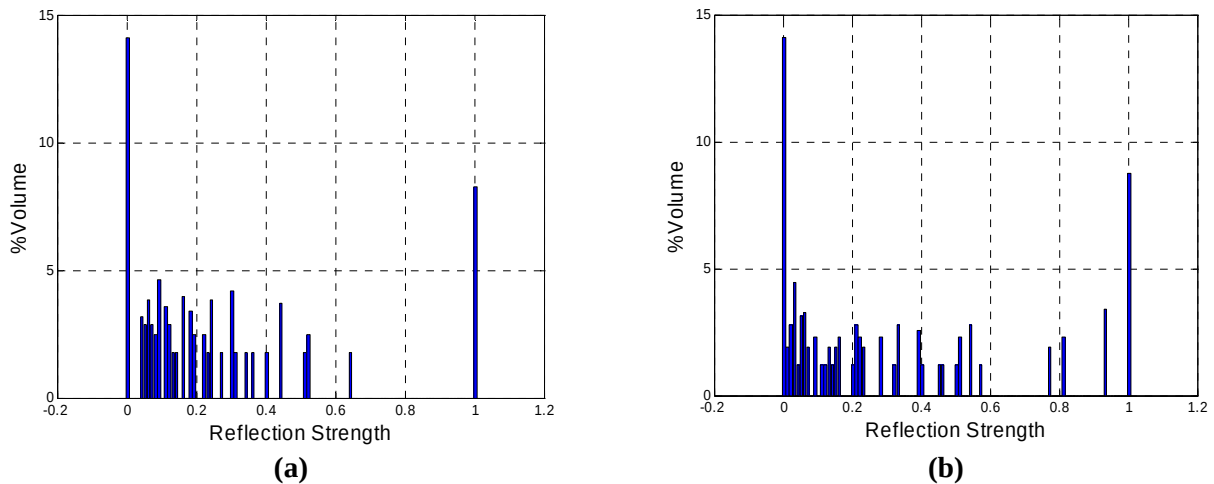
**FIGURE 10** Histogram of Reflection Intensity. Carter Creek Bridge (a), Van Buren Bridge (b).  
Log(%volume(at each reflection strength)) + constant.

A histogram is the graphical version of a table which shows what proportion of cases fall into each of several or many specified categories. In Fig. 10, the histograms of both bridges are shown. It is worthy noting that the percentage of volume of strong reflection intensity in Carter Creek Bridge is less than Van Buren Bridge, which supports the previous analysis that the latter one is more deteriorated.

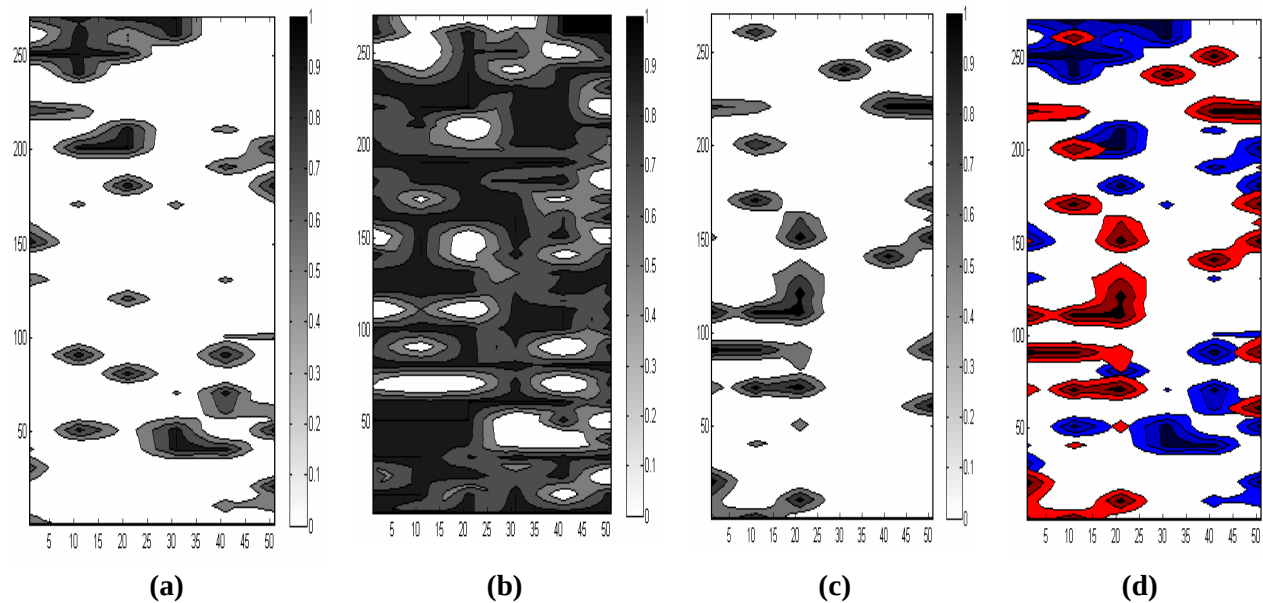
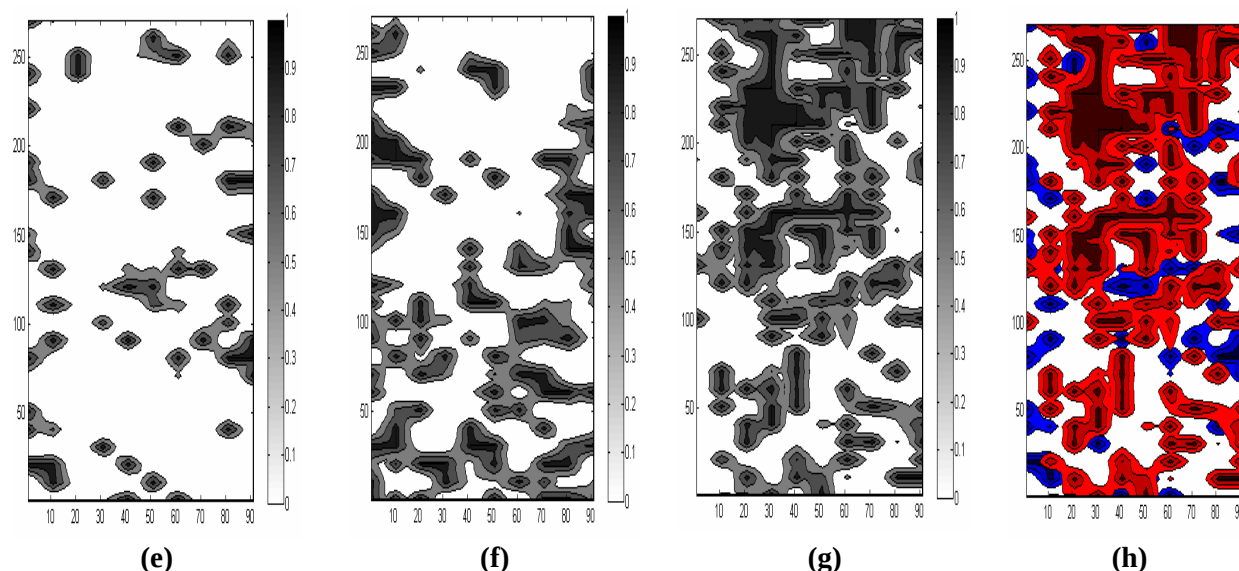
**FIGURE 11** Plan view contour plots for deck repair. Top: Carter Creek Bridge, Bottom: Van Buren Bridge. Left to right: the maximum reflectance in the “delamination zone” slice (0.07m~0.13m) (a)(e), in the “bottom of the deck” slice (0.16m~0.24m)(b)(f), and in the “apparent deep reflector” zone (0.3m~1m)(c)(g). Identified deteriorated zones (d) and (h) (red - serious condition, blue – fair to poor condition).

From the practical point, of highest interest and benefit is identification of zones on the deck that are in serious condition (progressed delamination) or fair to poor condition (initial delamination). The process of identification of such zones is illustrated in Figure 11. Initial delamination (fair to poor conditions) is primarily identified by medium to strong reflections at the depth corresponding to the position of the top rebars. This is illustrated in Figures 11a and 11e for Carter Creek and Van Buren bridges, respectively,

with strong reflection maps for slices between 7 and 13 cm. Similarly, sound zones of the deck are identified by strong reflections from the bottom of the deck, or in this case described by slices between 16 and 24 cm depth in Figures 11b and 11f. (Clearly, the Carter Creek Bridge deck is in a better condition.) Finally, progressed delamination (serious condition) can be described by strong reflection maps for the slice for the depth deeper than the depth of the bottom of the deck. This is illustrated by the strong reflection maps for slices between 30 cm and 1 m in Figures 11c and 11g. To obtain the map of zones candidates for repair, the map for serious condition is superimposed on the map of initial delamination, as e.g. repair map in Figure 11d is obtained from the map in Figures 11c superimposed on the map in Figure 11a. A comparison of maps for Carter Creek Bridge in Figure 11d and Van Buren Bridge in Figure 11h points clearly to significantly higher deterioration and need for repair of the latter one.
