# **CAVITATION EROSION OF ENGINEERING MATERIALS**

**THESIS PRESENTED FOR THE  
DEGREE OF DOCTOR OF  
PHILOSOPHY**

**DEPARTMENT OF MECHANICAL  
ENGINEERING AND AERONAUTICS  
THE CITY UNIVERSITY  
LONDON**

**AUGUST 1993**

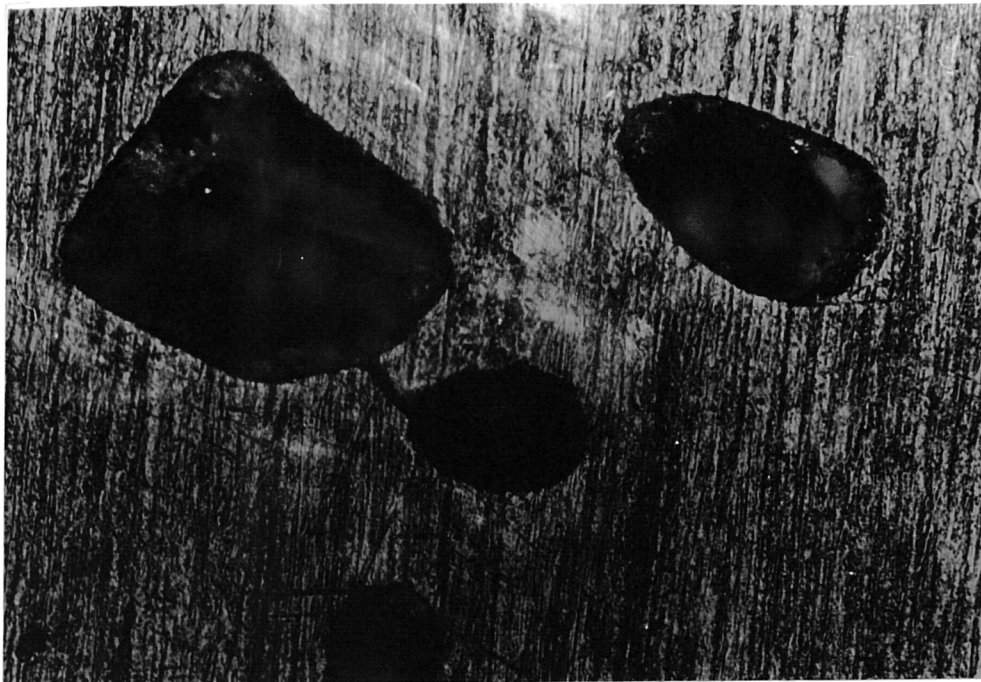
**FIG.108** OPTICAL MICROGRAPH OF SURFACE OF GRP  
SHOWING PORES DISPOSITION PRIOR TESTING

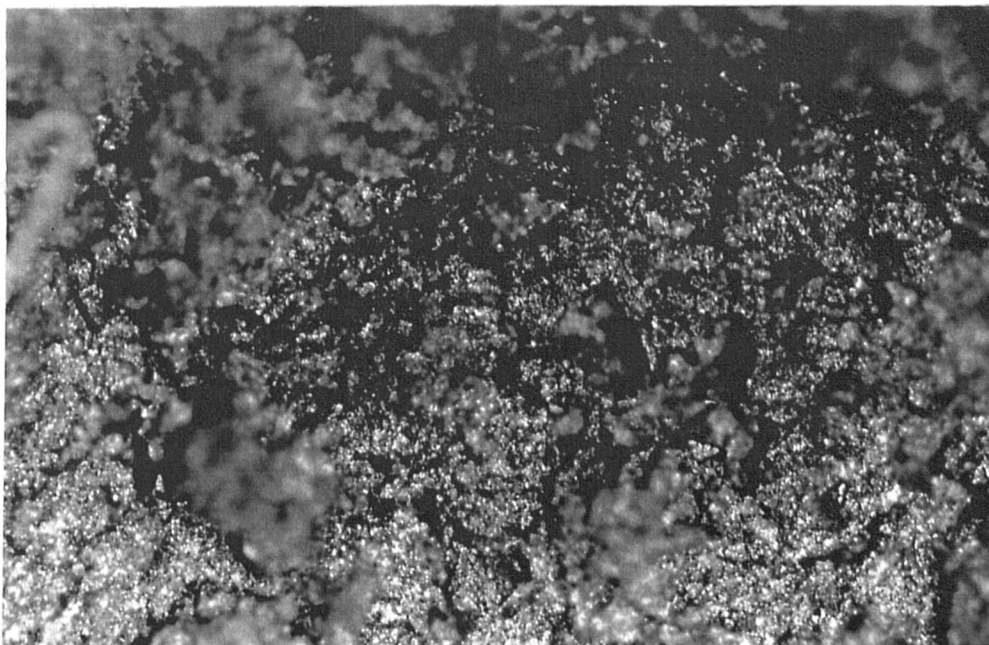
**FIG.117e** OPTICAL MICROGRAPH OF DAMAGE IN CENTRAL  
ZONE IN TOOL STEEL (380.min.)

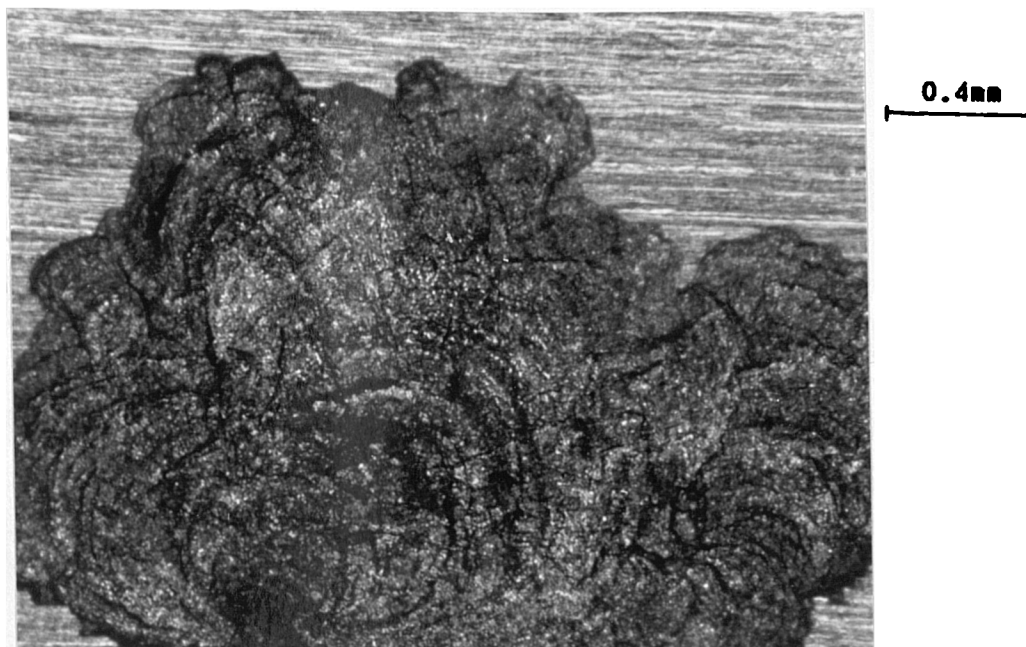
**FIG.118f** OPTICAL MICROGRAPH OF A SPALLED SURFACE TOPOGRAPHY  
IN NITRIDED STEEL
