## Remoulding of the Mercia Mudstone Group around CFA pile shafts

Observations of the remoulded zone around continuous flight auger piles constructed in the Mercia Mudstone Group

**Abstract:** A field test has been undertaken to investigate changes to *in situ* Mercia Mudstone at the pile soil interface after installation of four 5.5 m long 350 mm diameter CFA piles. The test investigated whether a remoulded zone exists, the extent of the zone, changes caused by remoulding and the effect of the installation method. The piles and surrounding soil were excavated after installation to a depth of just under 2 m. The sections of pile and surrounding soil were returned to the laboratory where a variety of detailed observations at both micro and macroscopic scales were undertaken, together with chemical and mineralogical analysis. It was found that a remoulded zone existed in all piles but that this varied in thickness both laterally and vertically around a pile. Across all piles the maximum thickness observed was 55 mm. The average thickness, fabric and texture were all affected by installation method. A distinctive vertically orientated fabric was observed in which up to four vertical

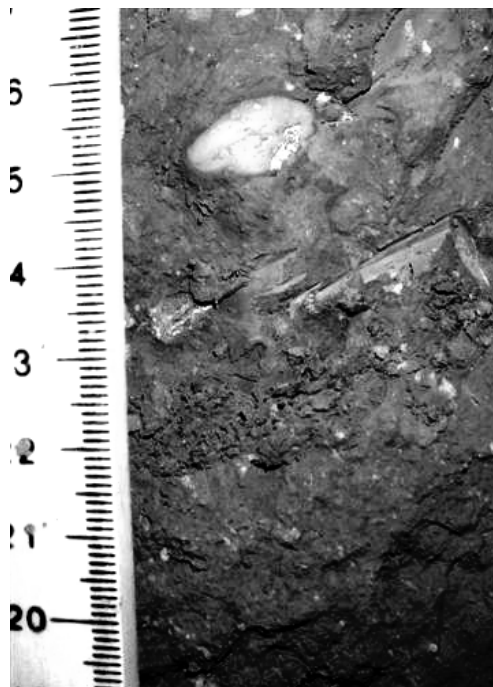
Figure 6 The vertical elevation of the remoulded surface of pile MR2 showing free aggregates within the remoulded layers. 1000-1457mm bgl.

Around all piles, pieces of aggregate were found within the remoulded zone, which were unlike anything occurring naturally in the geology on site (Figure 6). These aggregates have therefore been assumed to
