**Citation:** Papathanasiou, S., Szczepura, K. & Thompson, J. D. (2025). The impact of technical and environmental conditions on the quality assessment in mammography. *Radiography*, 31(1), pp. 131-136. doi: 10.1016/j.radi.2024.10.013

# The impact of technical and environmental conditions on the quality assessment in mammography

**Introduction:** Mammography requires optimal image quality and that should be ensured during quality assurance. This study investigates the impact of environmental conditions and monitor specifications on quality control procedures within image acquisition rooms in breast imaging departments.

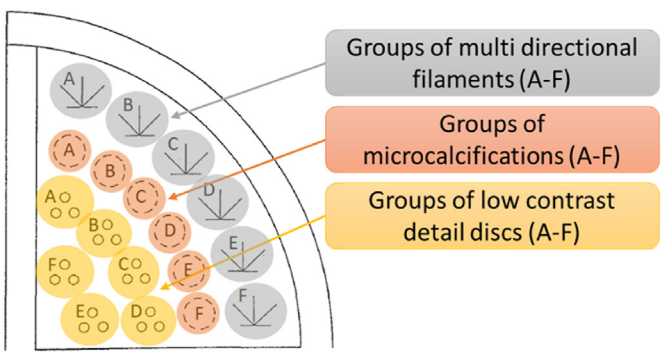
Figure 1. Schematic representation of a TORMAM phantom image. Representation of the different structures within the test object image.

During this experiment, nine different TORMAM phantom images (Fig. 1) were evaluated by 16 participants. The aim for this research was to recruit more than 14 participants for good statistical power.<sup>15</sup> This would help with the generalizability of the results and account for inter-observer variation. All participants were registered radiographers with 2–15 years experience in mammography. Those who agreed to take part received a participant information sheet and signed a consent form; they could

During the experiment the participants had to perform a technical image evaluation of the top half of the TORMAM image (Fig. 1) under three different illumination levels (25, 75, 500 lux), with grey (reflectance value 30 %) and white (reflectance value 87 %) wall colours and on both monitors. Each colour has a characteristic reflectance value which is the total quantity of visible light reflected by a surface.<sup>18,19</sup> They were required to identify only the structures they could see in their entirety; (i) all elements of the multi-directional filaments, (ii) the microcalcification clusters, and (iii) all three low contrast objects in each group (Fig. 1). Participants recorded data manually in a data collection sheet.

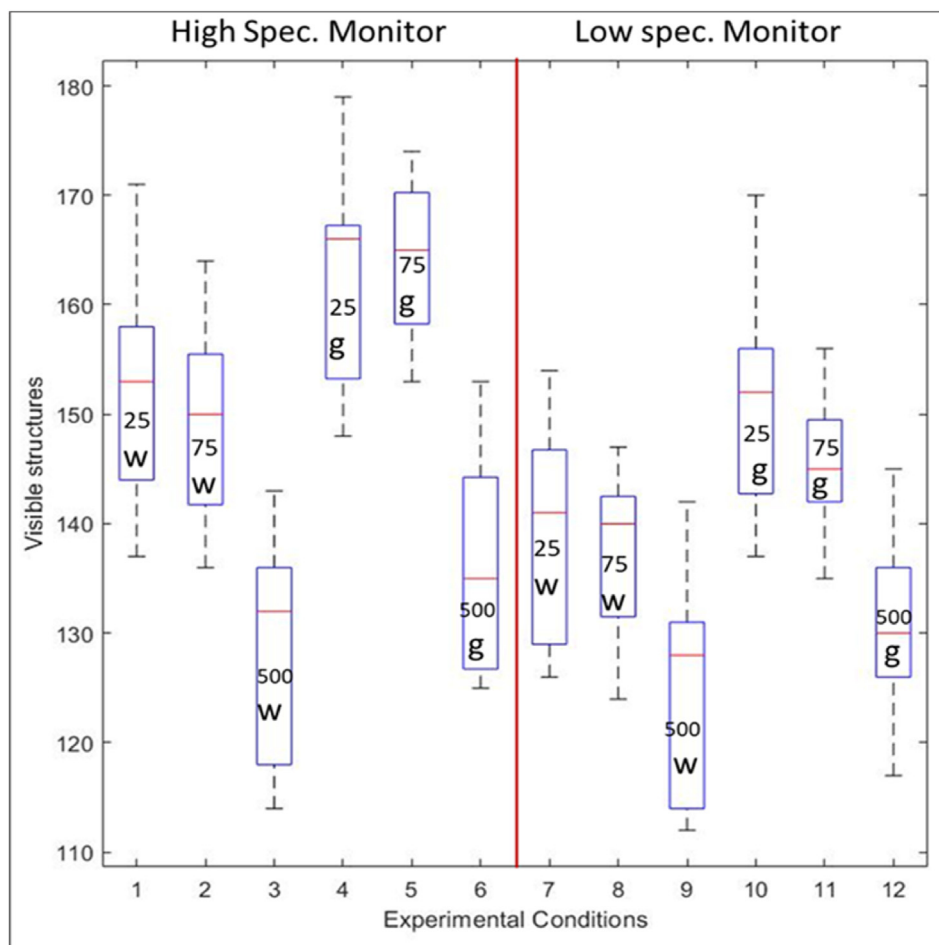
**Figure 2.** Experimental conditions are shown on the x-axis; for all ambient light levels and wall colours, for each monitor (HRM and LRM specification). The number of all visible structures was fewer at an ambient light of 500 lux compared to both 25 and 75 lux. In addition, structure visibility was better with a grey wall colour at all ambient light levels. Paired comparison between monitors showed better structure visibility on the high specification monitor for all condition. (For interpretation of the references to colour in this figure legend, the reader is referred to the Web version of this article.)

The results from this experiment revealed that different environmental conditions lead to large variations in the number of visible of structures on the TORMAM images for both monitors (Fig. 2). A white wall colour and the brightest ambient light (500 lux) lead to a statistically significant reduction in the number of structures that were visible. The results of this experiment showed
